BROOKHAVEN NATIONAL LABORATORY

MAGNET DIVISION NOTES

Author(s): Ramesh Gupta
Date: October 6, 1994
No: 545-16 (RHIC-MD-246)
Task Force: RHIC
Title: Analysis of QRJ105 Magnet with a Broken Shim

Analysis of QRJ105 Magnet with a Broken Shim

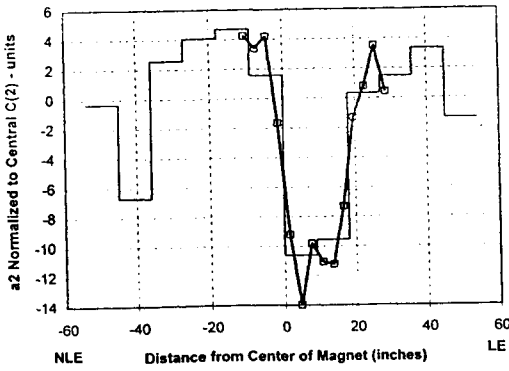
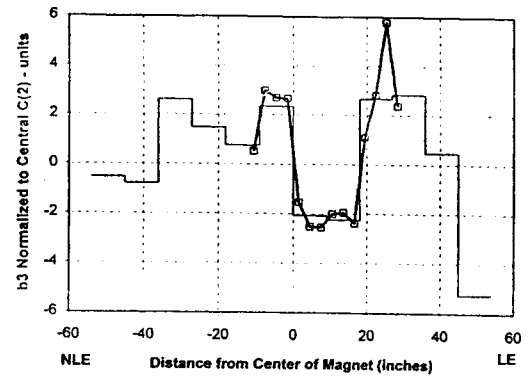
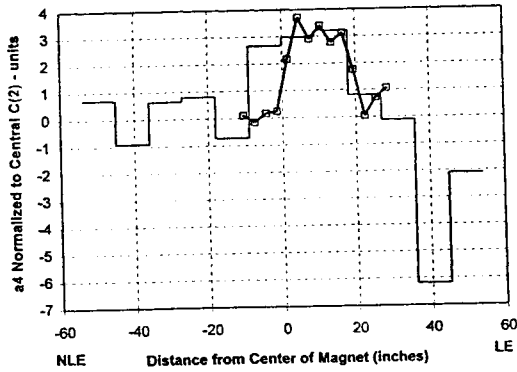
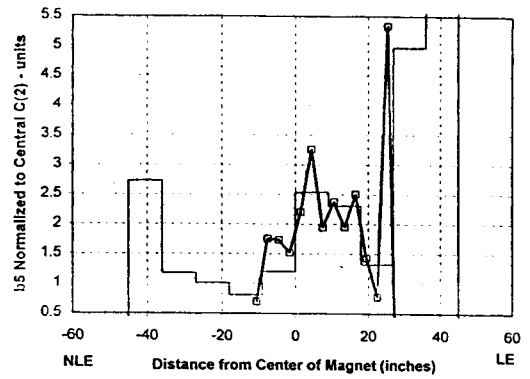
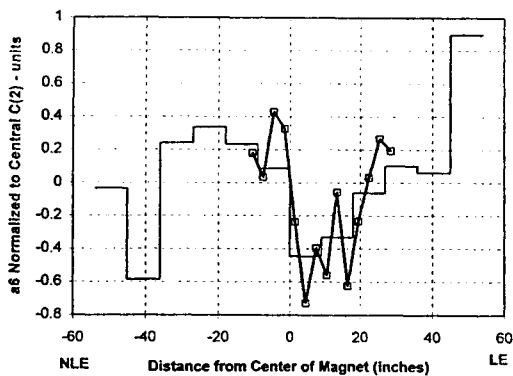
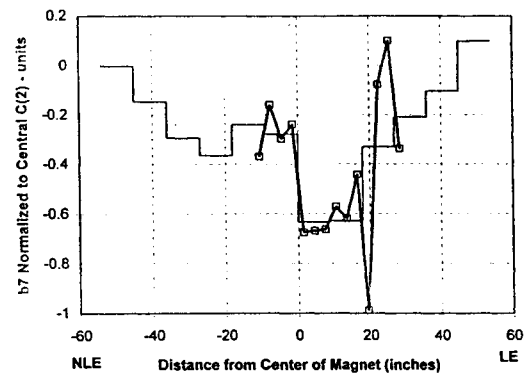
Figure 1: Measured axial-variation in field harmonics in 3" and 9" steps (courtesy A. Jain).

Based on this, a measurement of field harmonics in small steps was requested to localize the problem. As shown in figure 1, a large change in harmonics is seen in an 18" section near the center of the magnet which is towards the lead-end side. b_5 suggests a possible 0.012" to 0.016" error in overall dimension. A large value of a_2 (\sim -11 unit) suggests that a top-bottom symmetry is broken and that the dimensional errors mentioned above are not uniformly distributed (azimuthally) in the cross-section of that local area. Moreover, a large drop in b_3 suggests that the horizontal and vertical symmetry is also significantly broken. A visual inspection of the suspected area in the magnet revealed that a 0.014" shim between the two coils at 90 degree has broken off in about 18" long section.

Axial Variation of Harmonics in QRJ105 Harmonics Normalized to Central C(2)
