**BNL Quarterly Report on
Superconducting Magnetic Energy Storage
Prepared for ARPA-E
Through CRADA No. BNL-C-11-01
With ABB Inc.**

Q15 Progress Report and Status of Milestones

Damage Incurred in Inner Coil

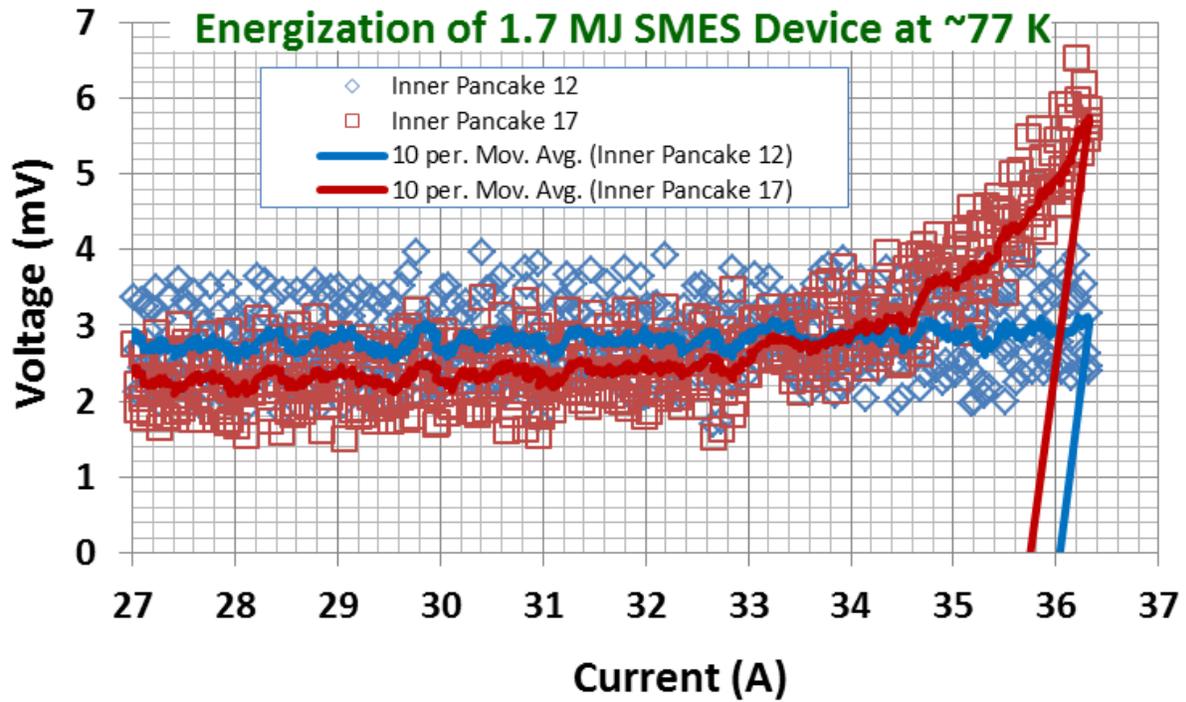
Figure 5 shows that the coil reached a little over 36 Amp at ~77 K. The quench protection system turned off the power supply and extracted the energy when the voltage threshold for detecting quench was exceeded. Thorough checks after the event showed no change in the status of coil and

all components of the diagnostic system (electronics, voltage-tap, etc.). This demonstrated the safe operation of a critical sub-system of the energy storage device.

Figure 5: Coil reached a little over 36 A at ~77 K. The quench protection system turned off the power supply and extracted the energy when the voltage threshold for detecting quench was exceeded.
