**BNL Quarterly Report on  
Superconducting Magnetic Energy Storage  
Prepared for ARPA-E  
Through CRADA No. BNL-C-11-01  
With ABB Inc.**

**Q15 Progress Report and Status of Milestones**

July 8, 2014

## **Damage Incurred in Inner Coil**

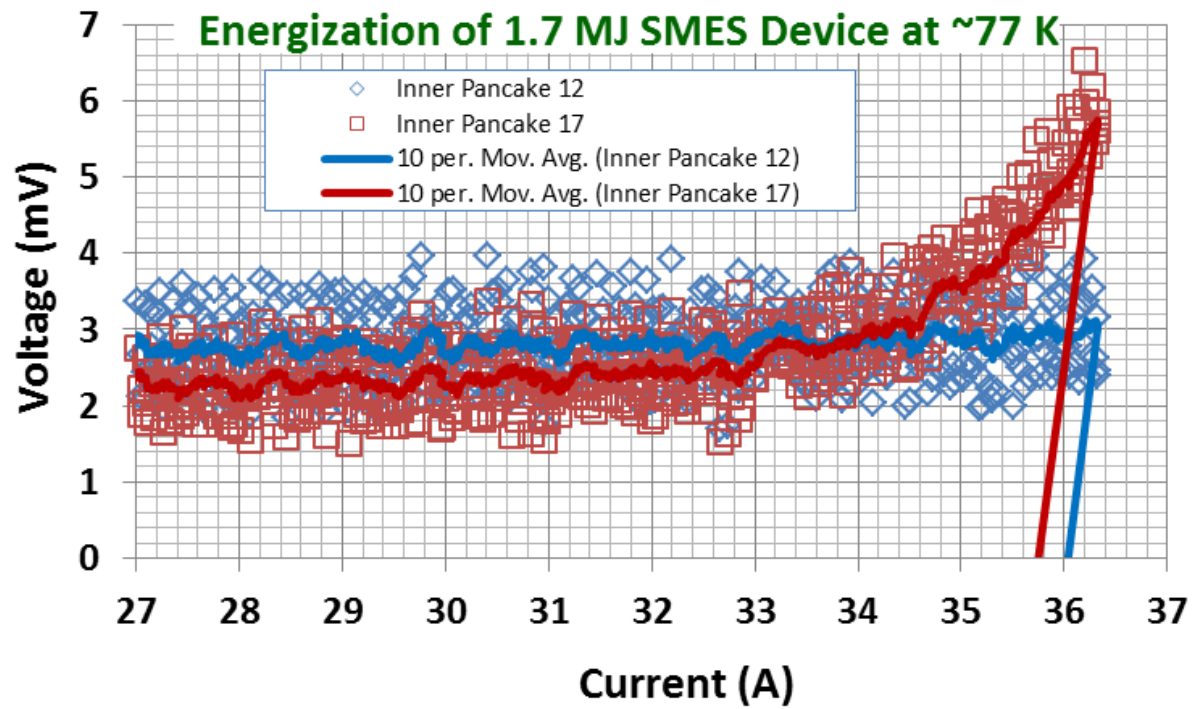
Figure 5 shows that the coil reached a little over 36 Amp at  $\sim 77$  K. The quench protection system turned off the power supply and extracted the energy when the voltage threshold for detecting quench was exceeded. Thorough checks after the event showed no change in the status of coil and all components of the diagnostic system (electronics, voltage-tap, etc.). This demonstrated the safe operation of a critical sub-system of the energy storage device.

*Figure 5: Coil reached a little over 36 A at ~77 K. The quench protection system turned off the power supply and extracted the energy when the voltage threshold for detecting quench was exceeded.*
