Measurements as a Tool to Monitor Magnet Production

US Particle Accelerator School on *Superconducting Accelerator Magnets*

Dipole Example from RHIC

Shorts in a Multilayer Magnet

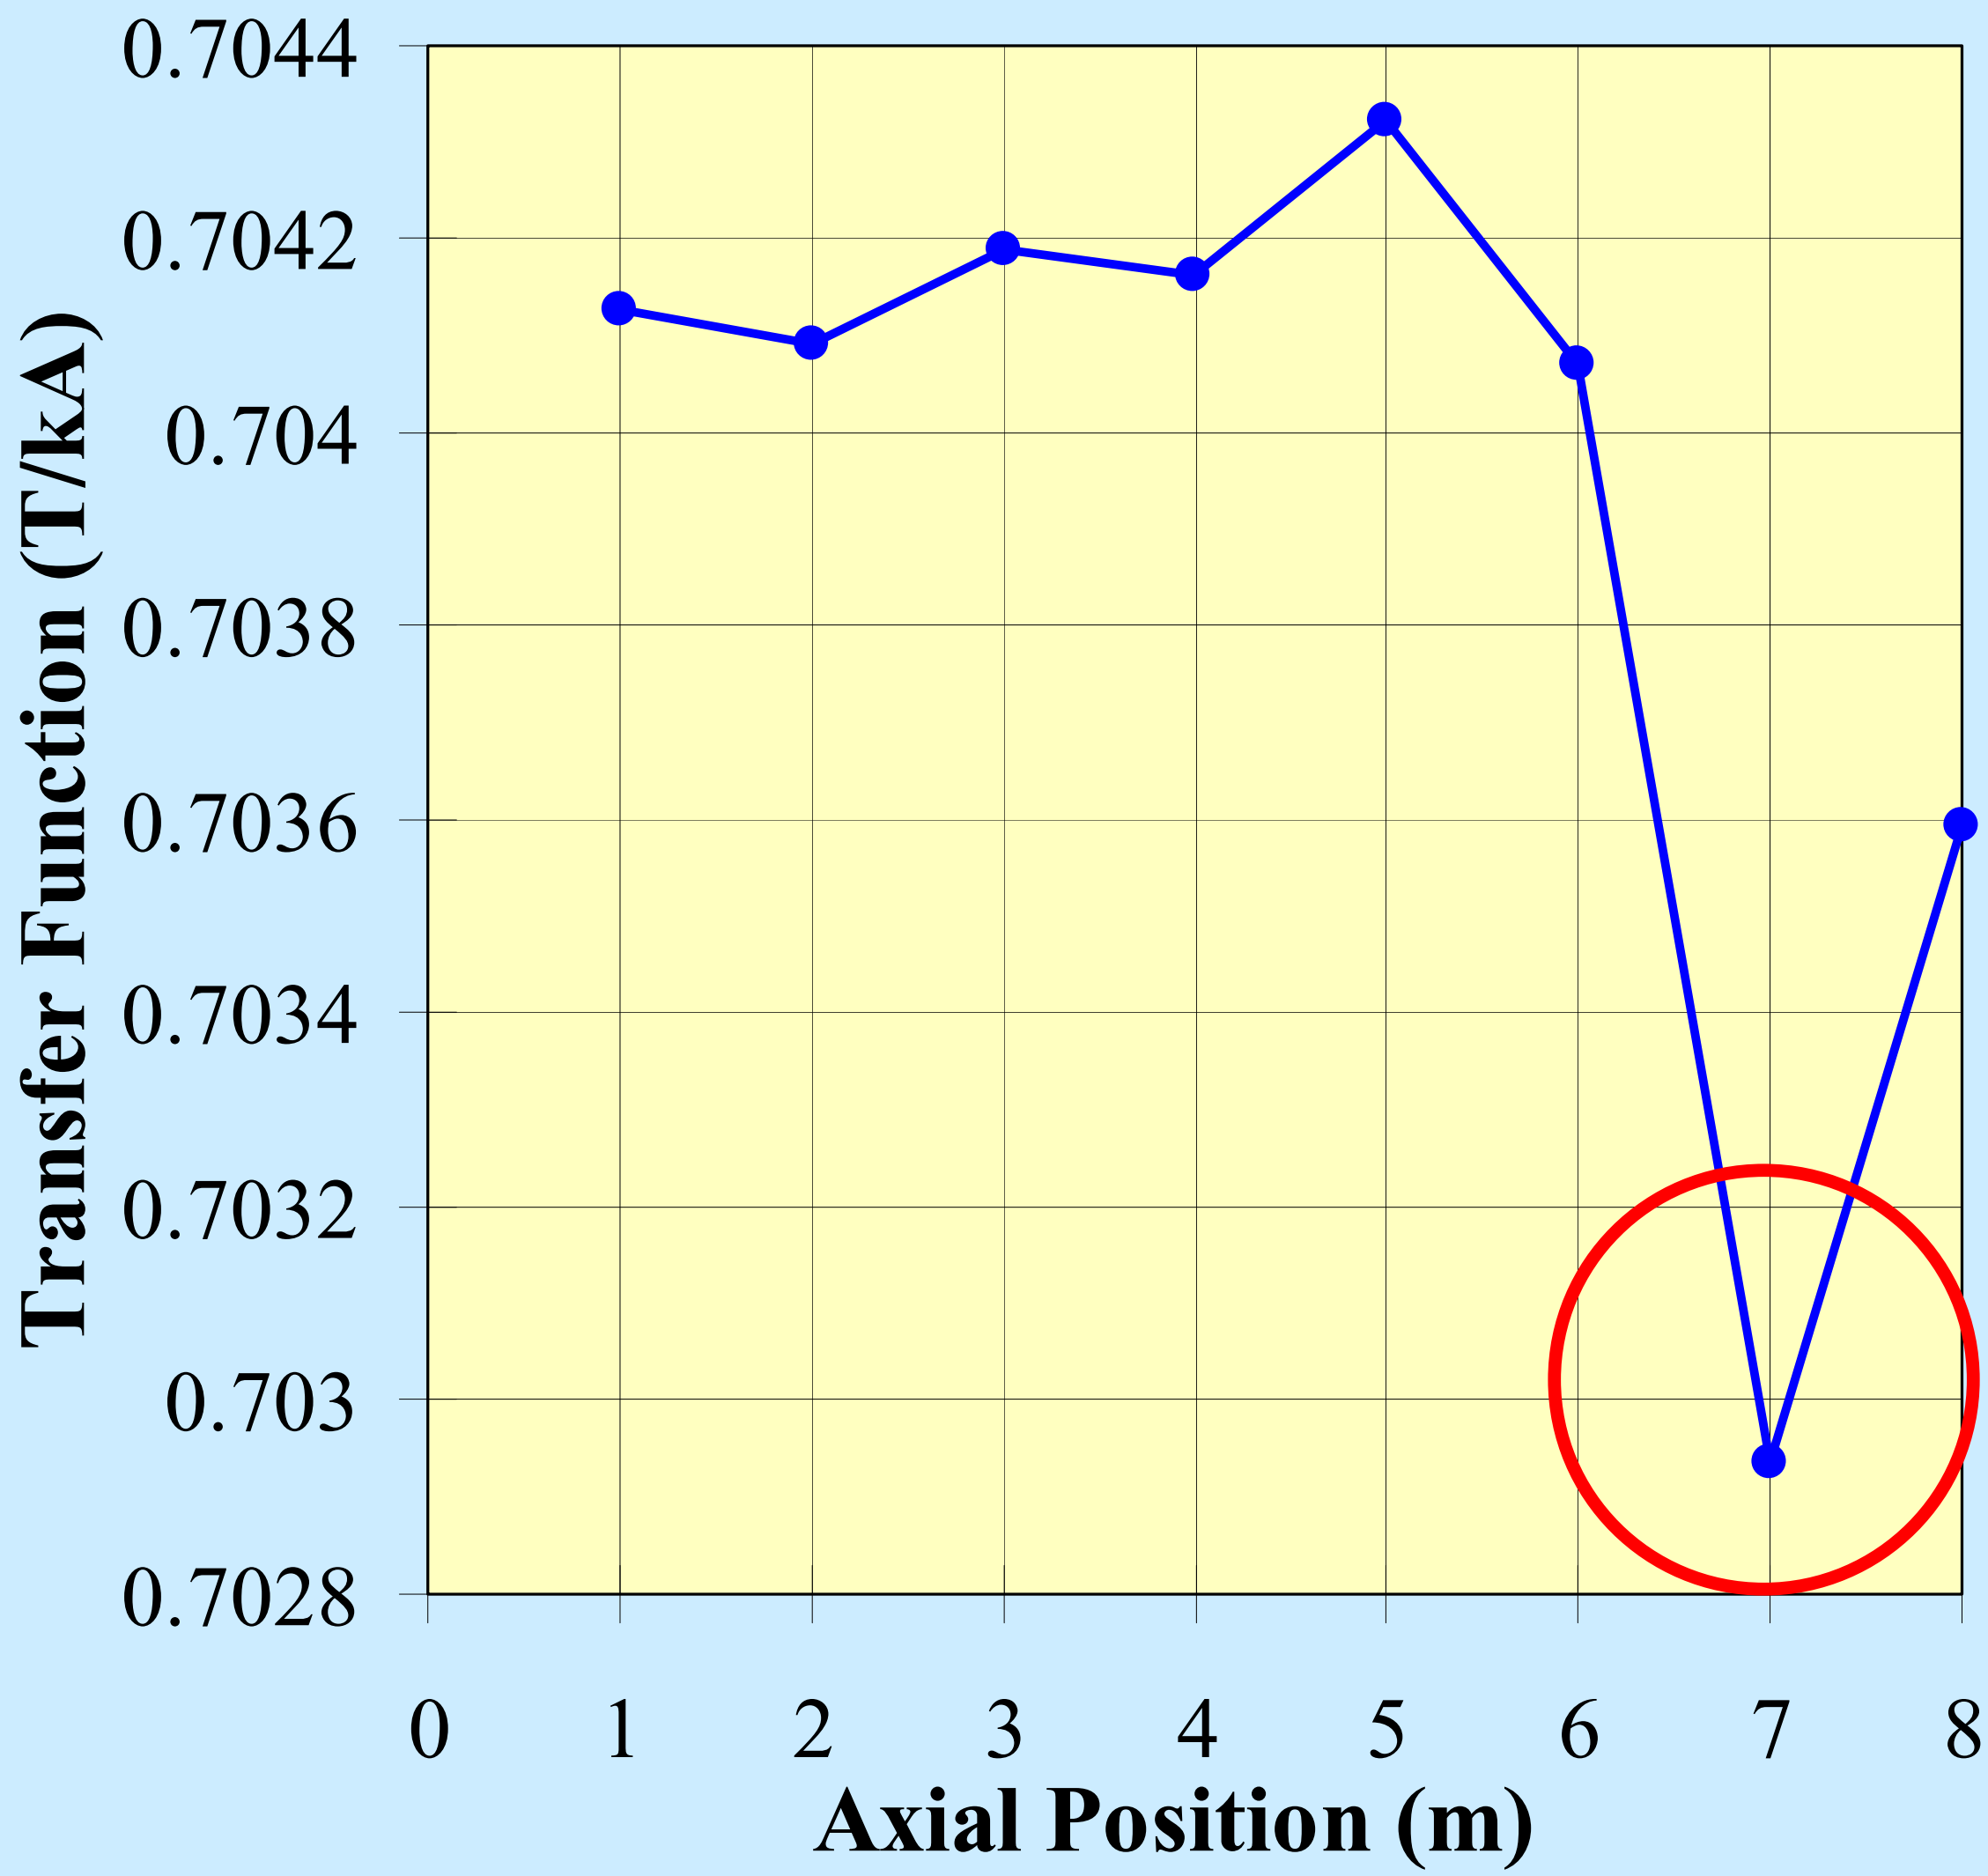
Dipole No. 149 (DRG189): Axial scan with 1 m long mole in 1 m steps

Warm meas. at the vendor's site showed an unusual drop in transfer function (0.18%) at one location.

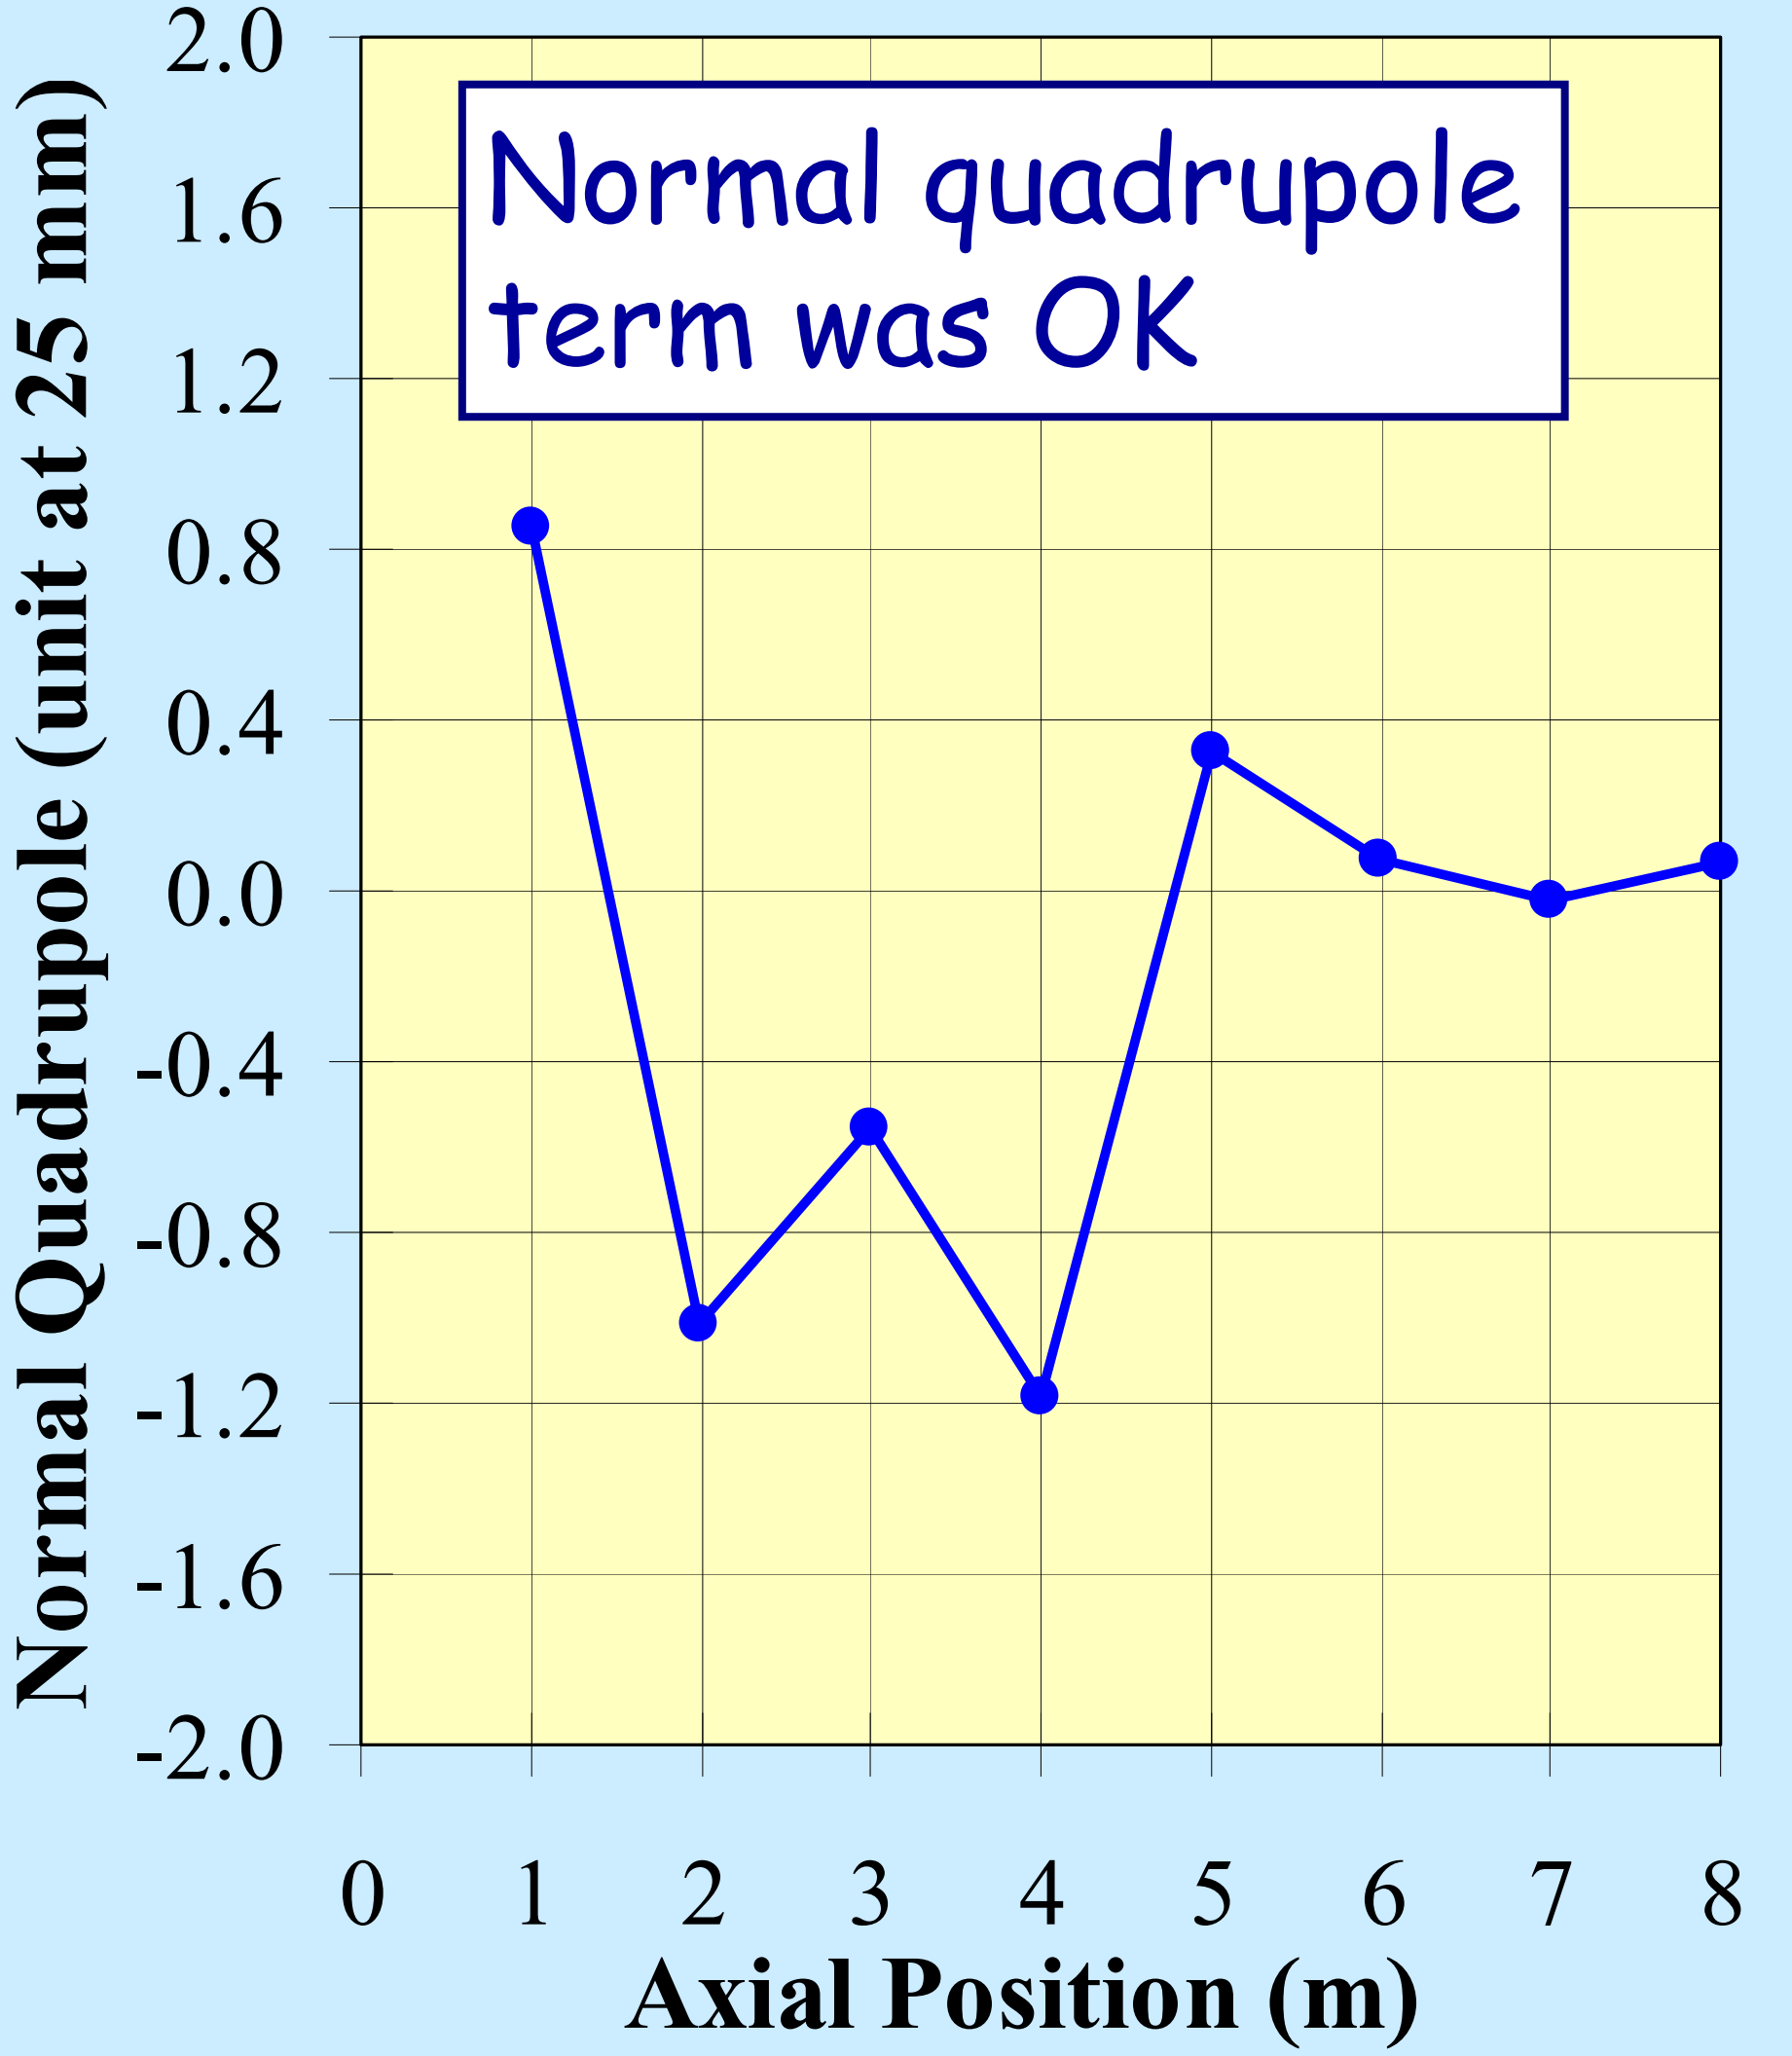
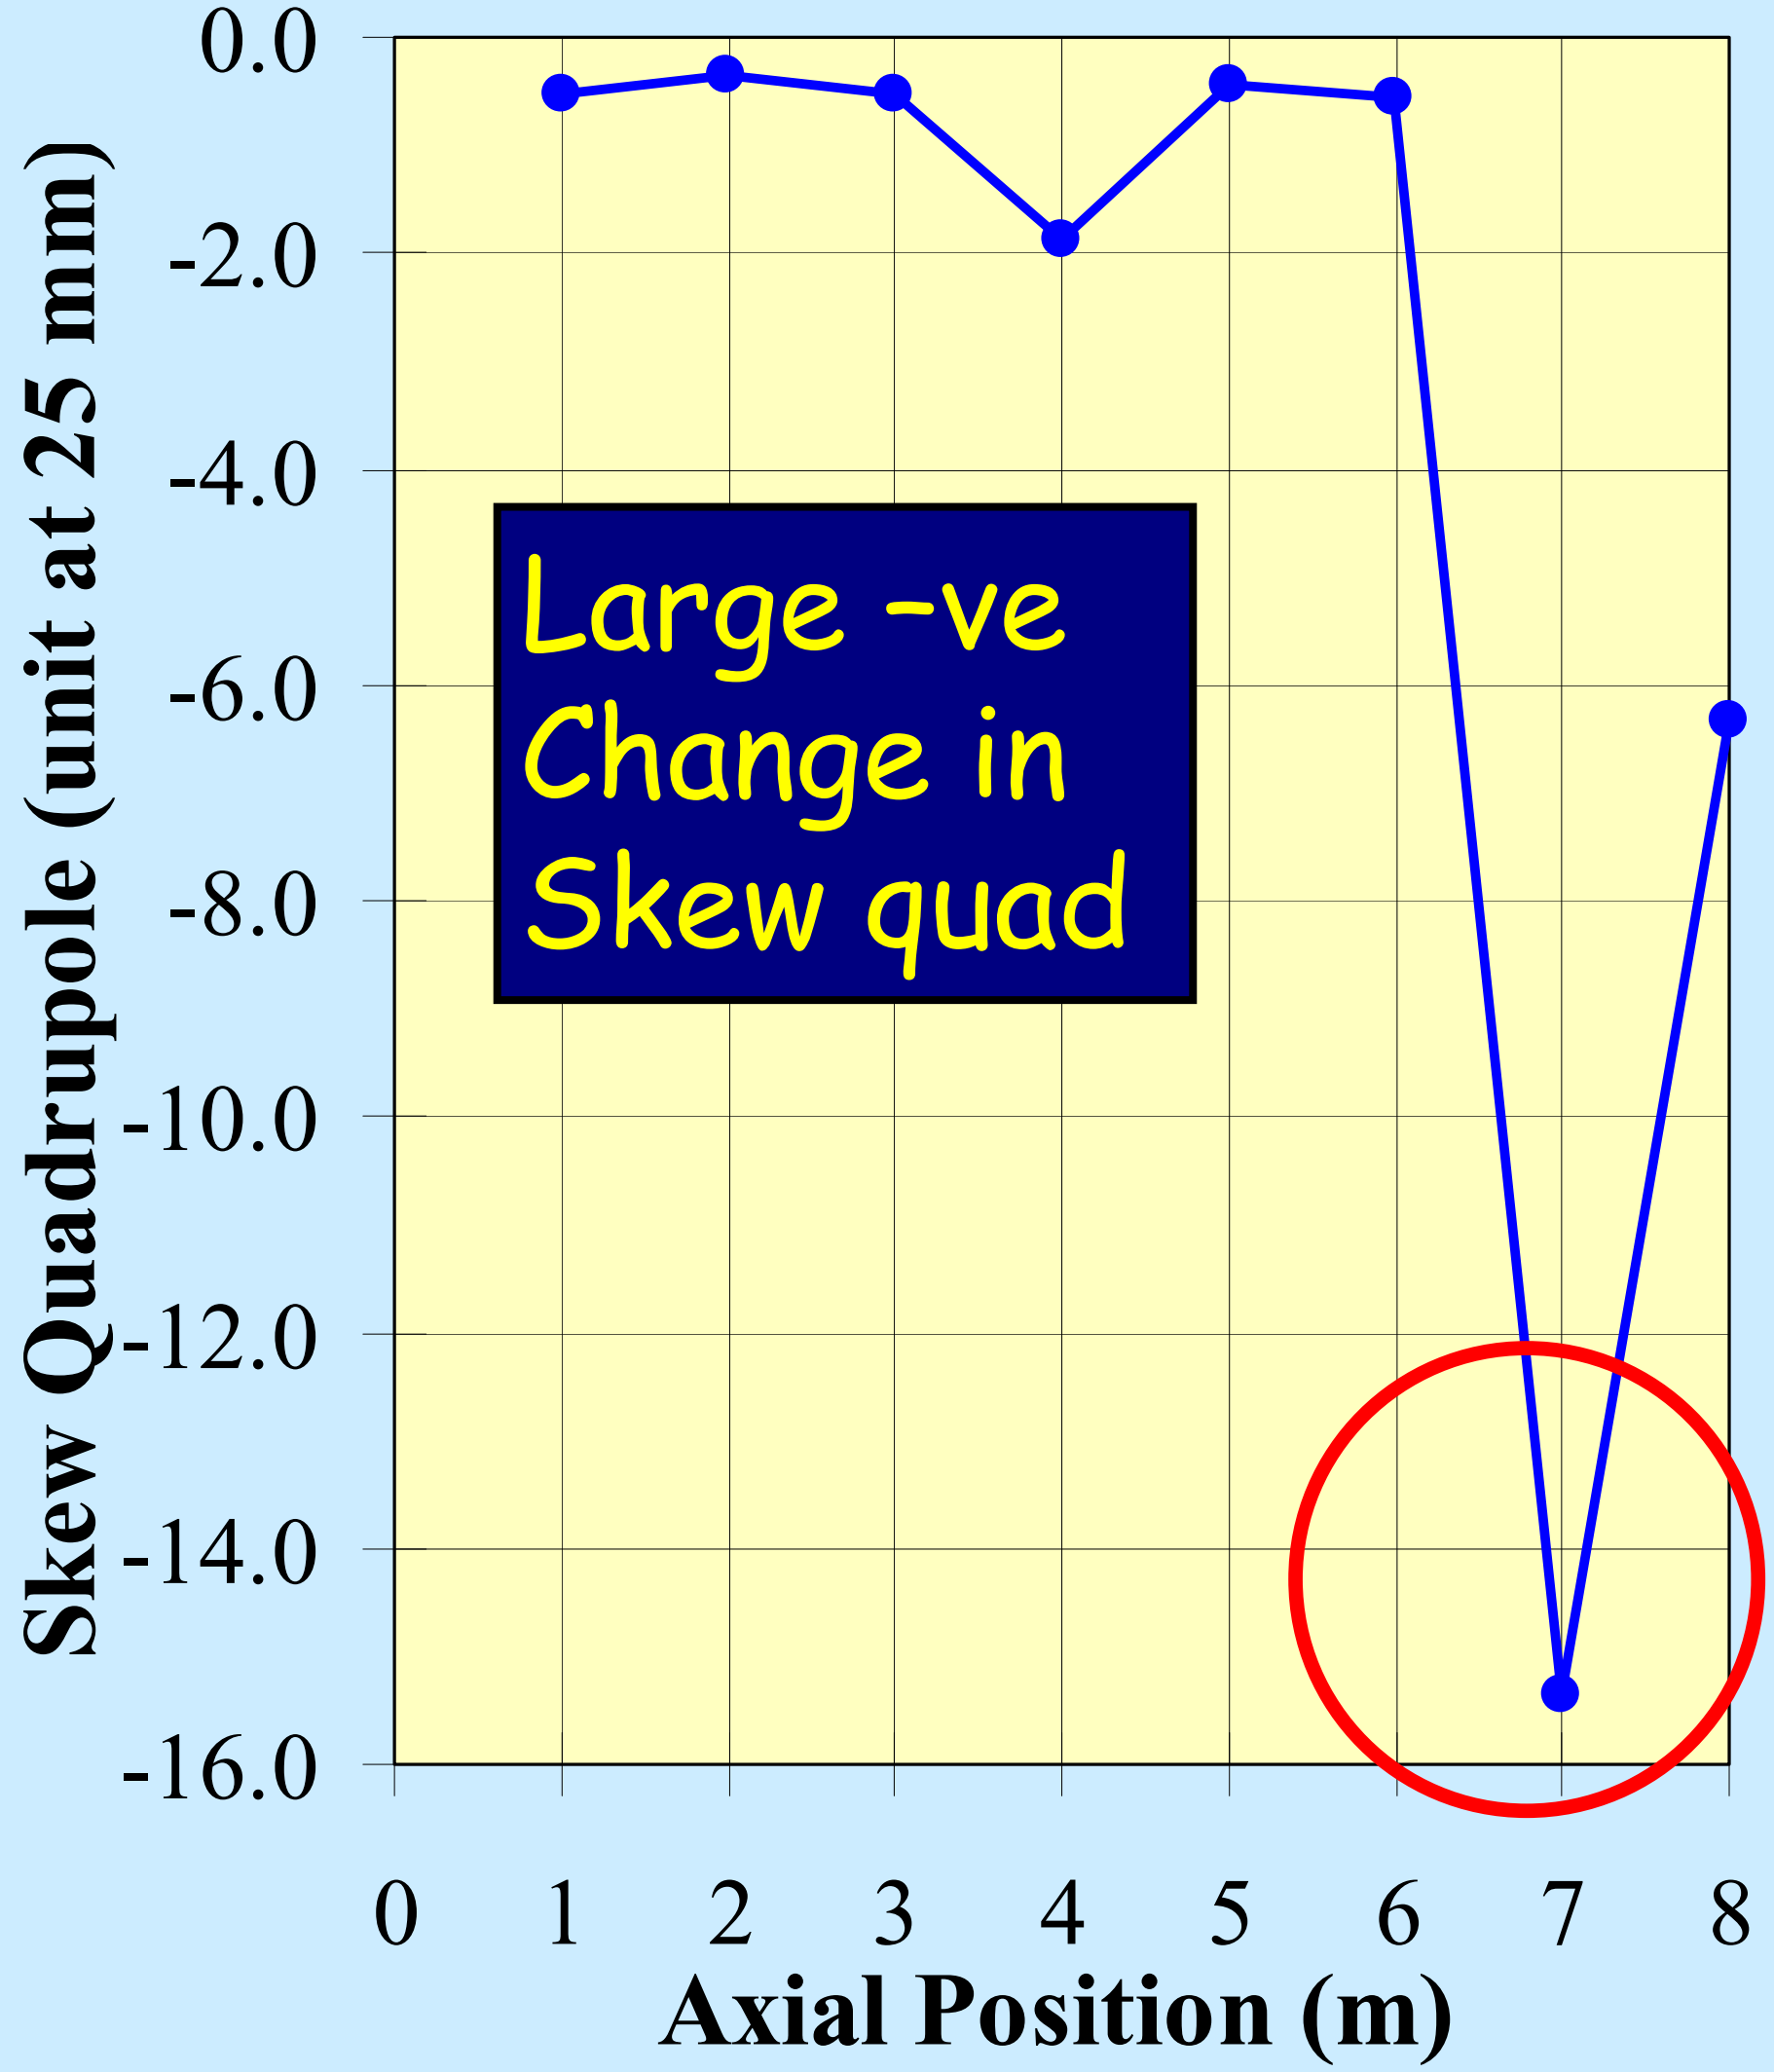
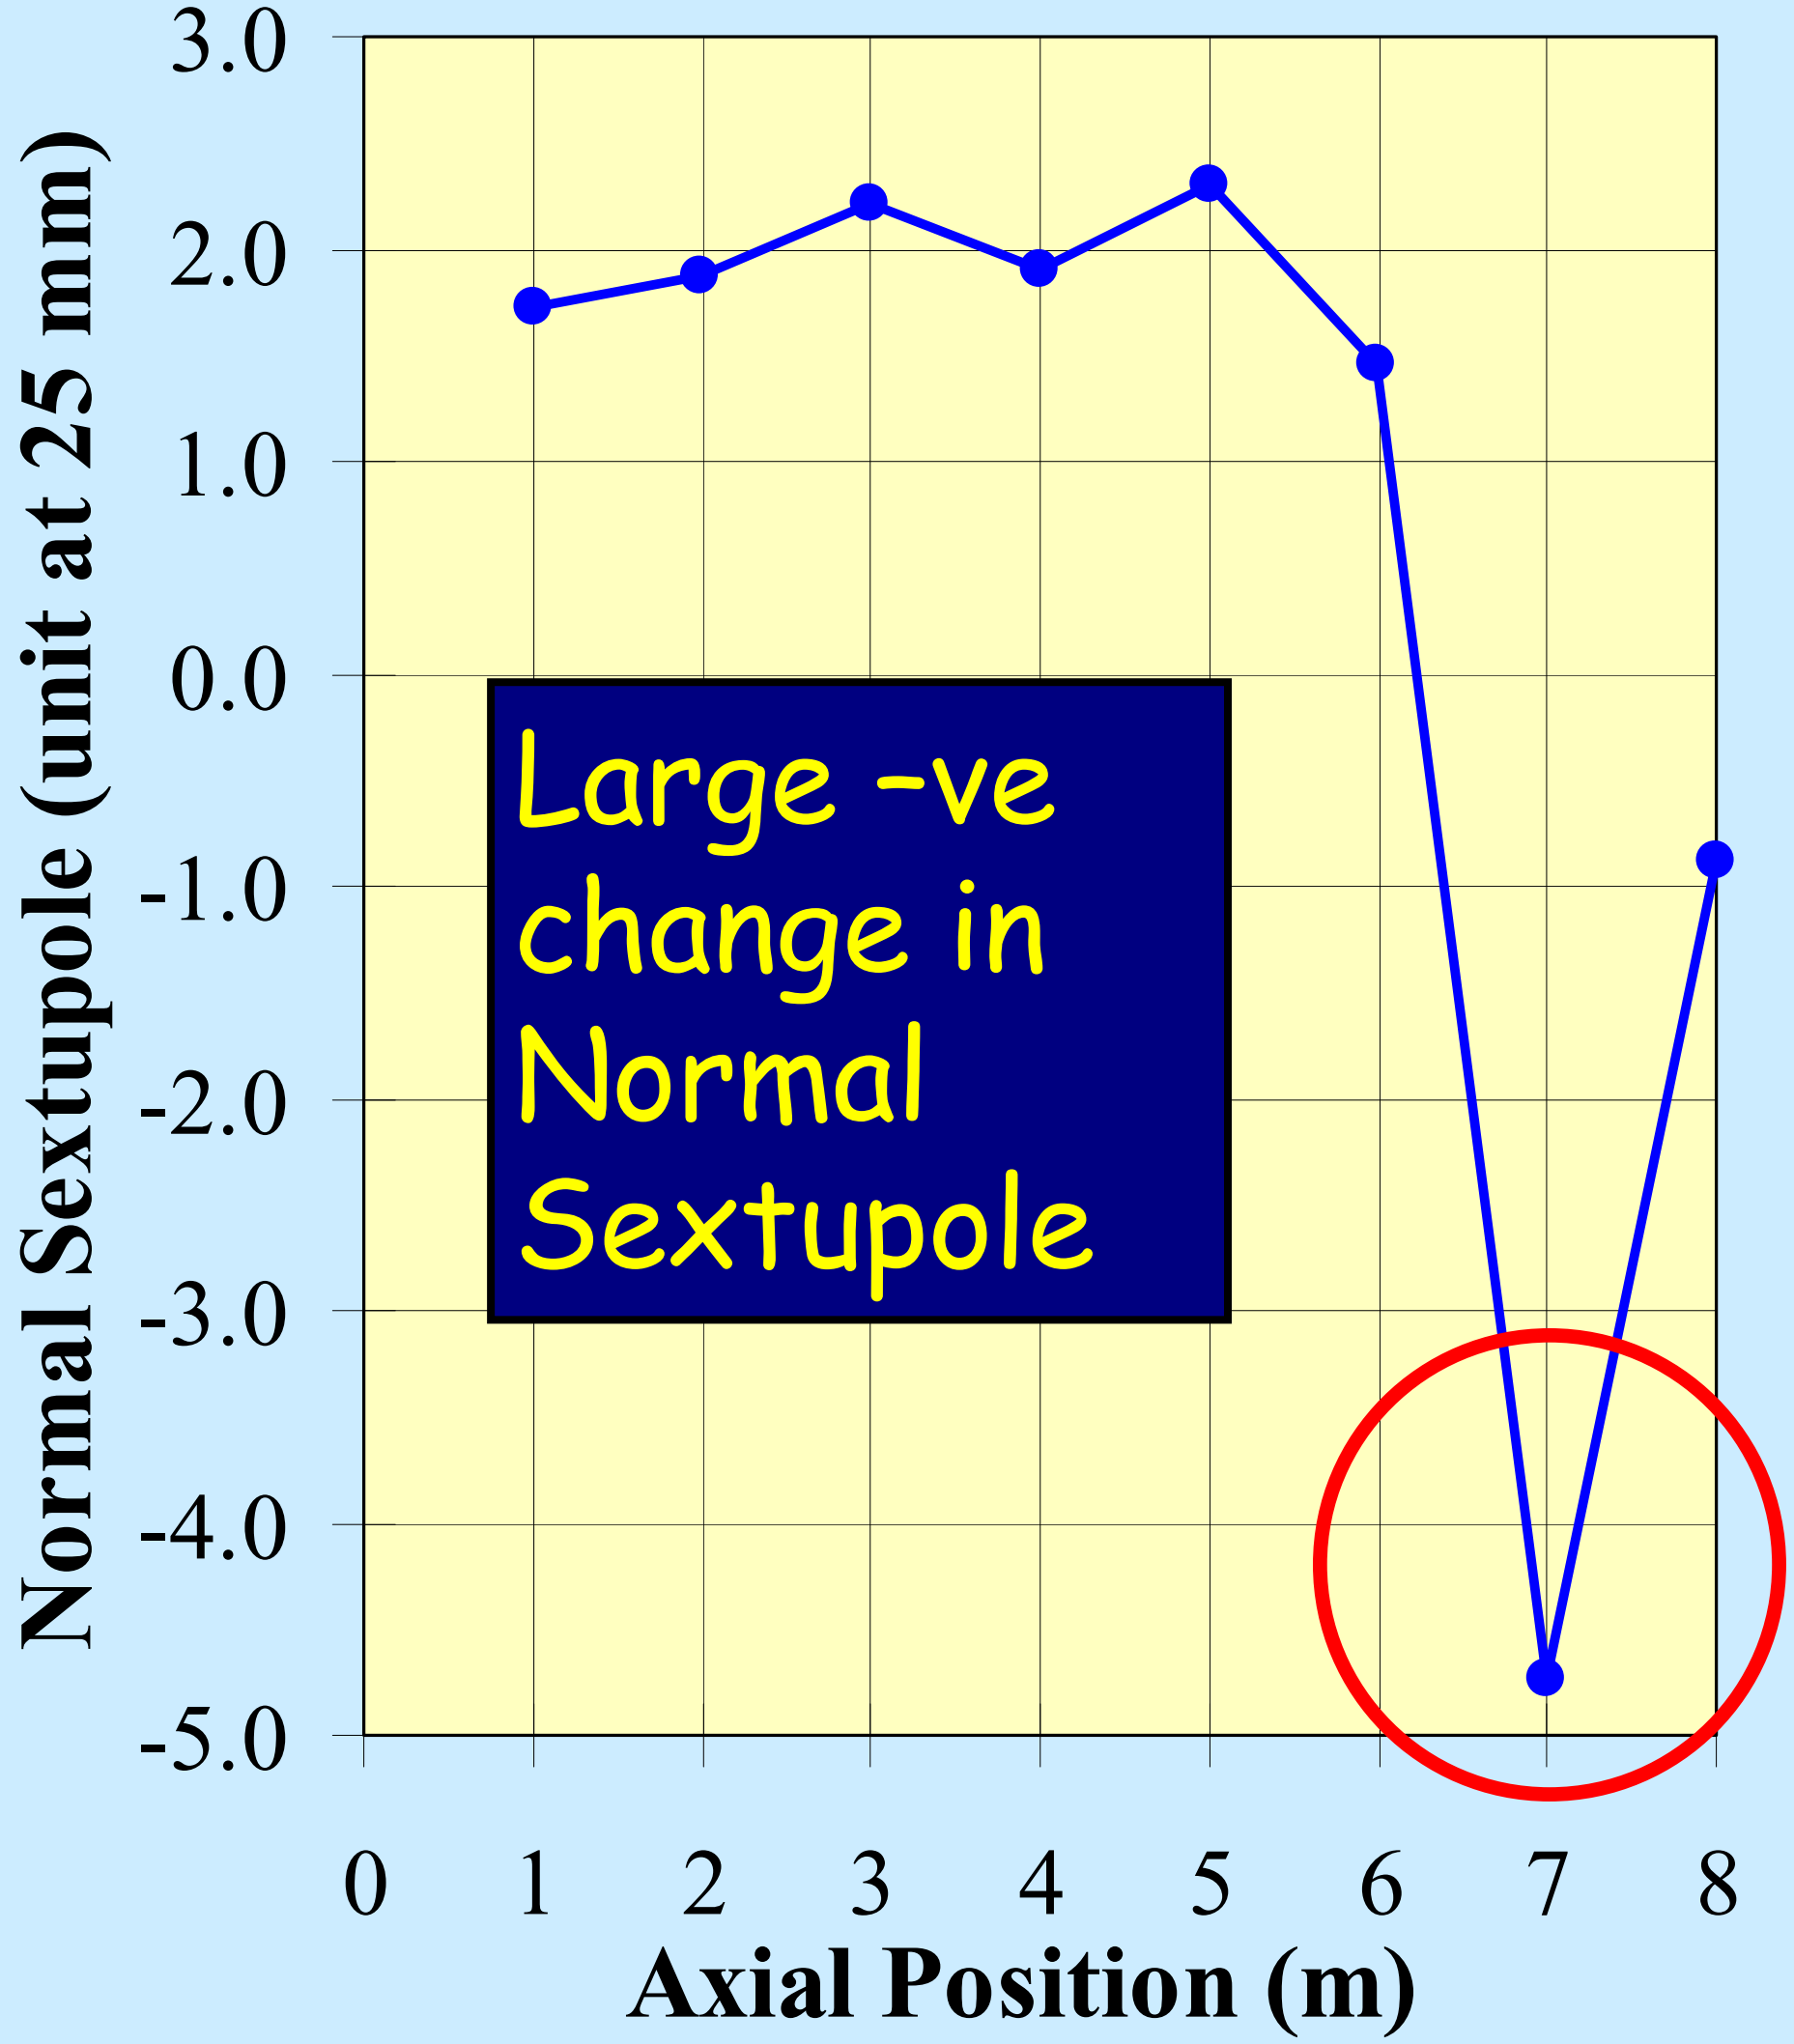
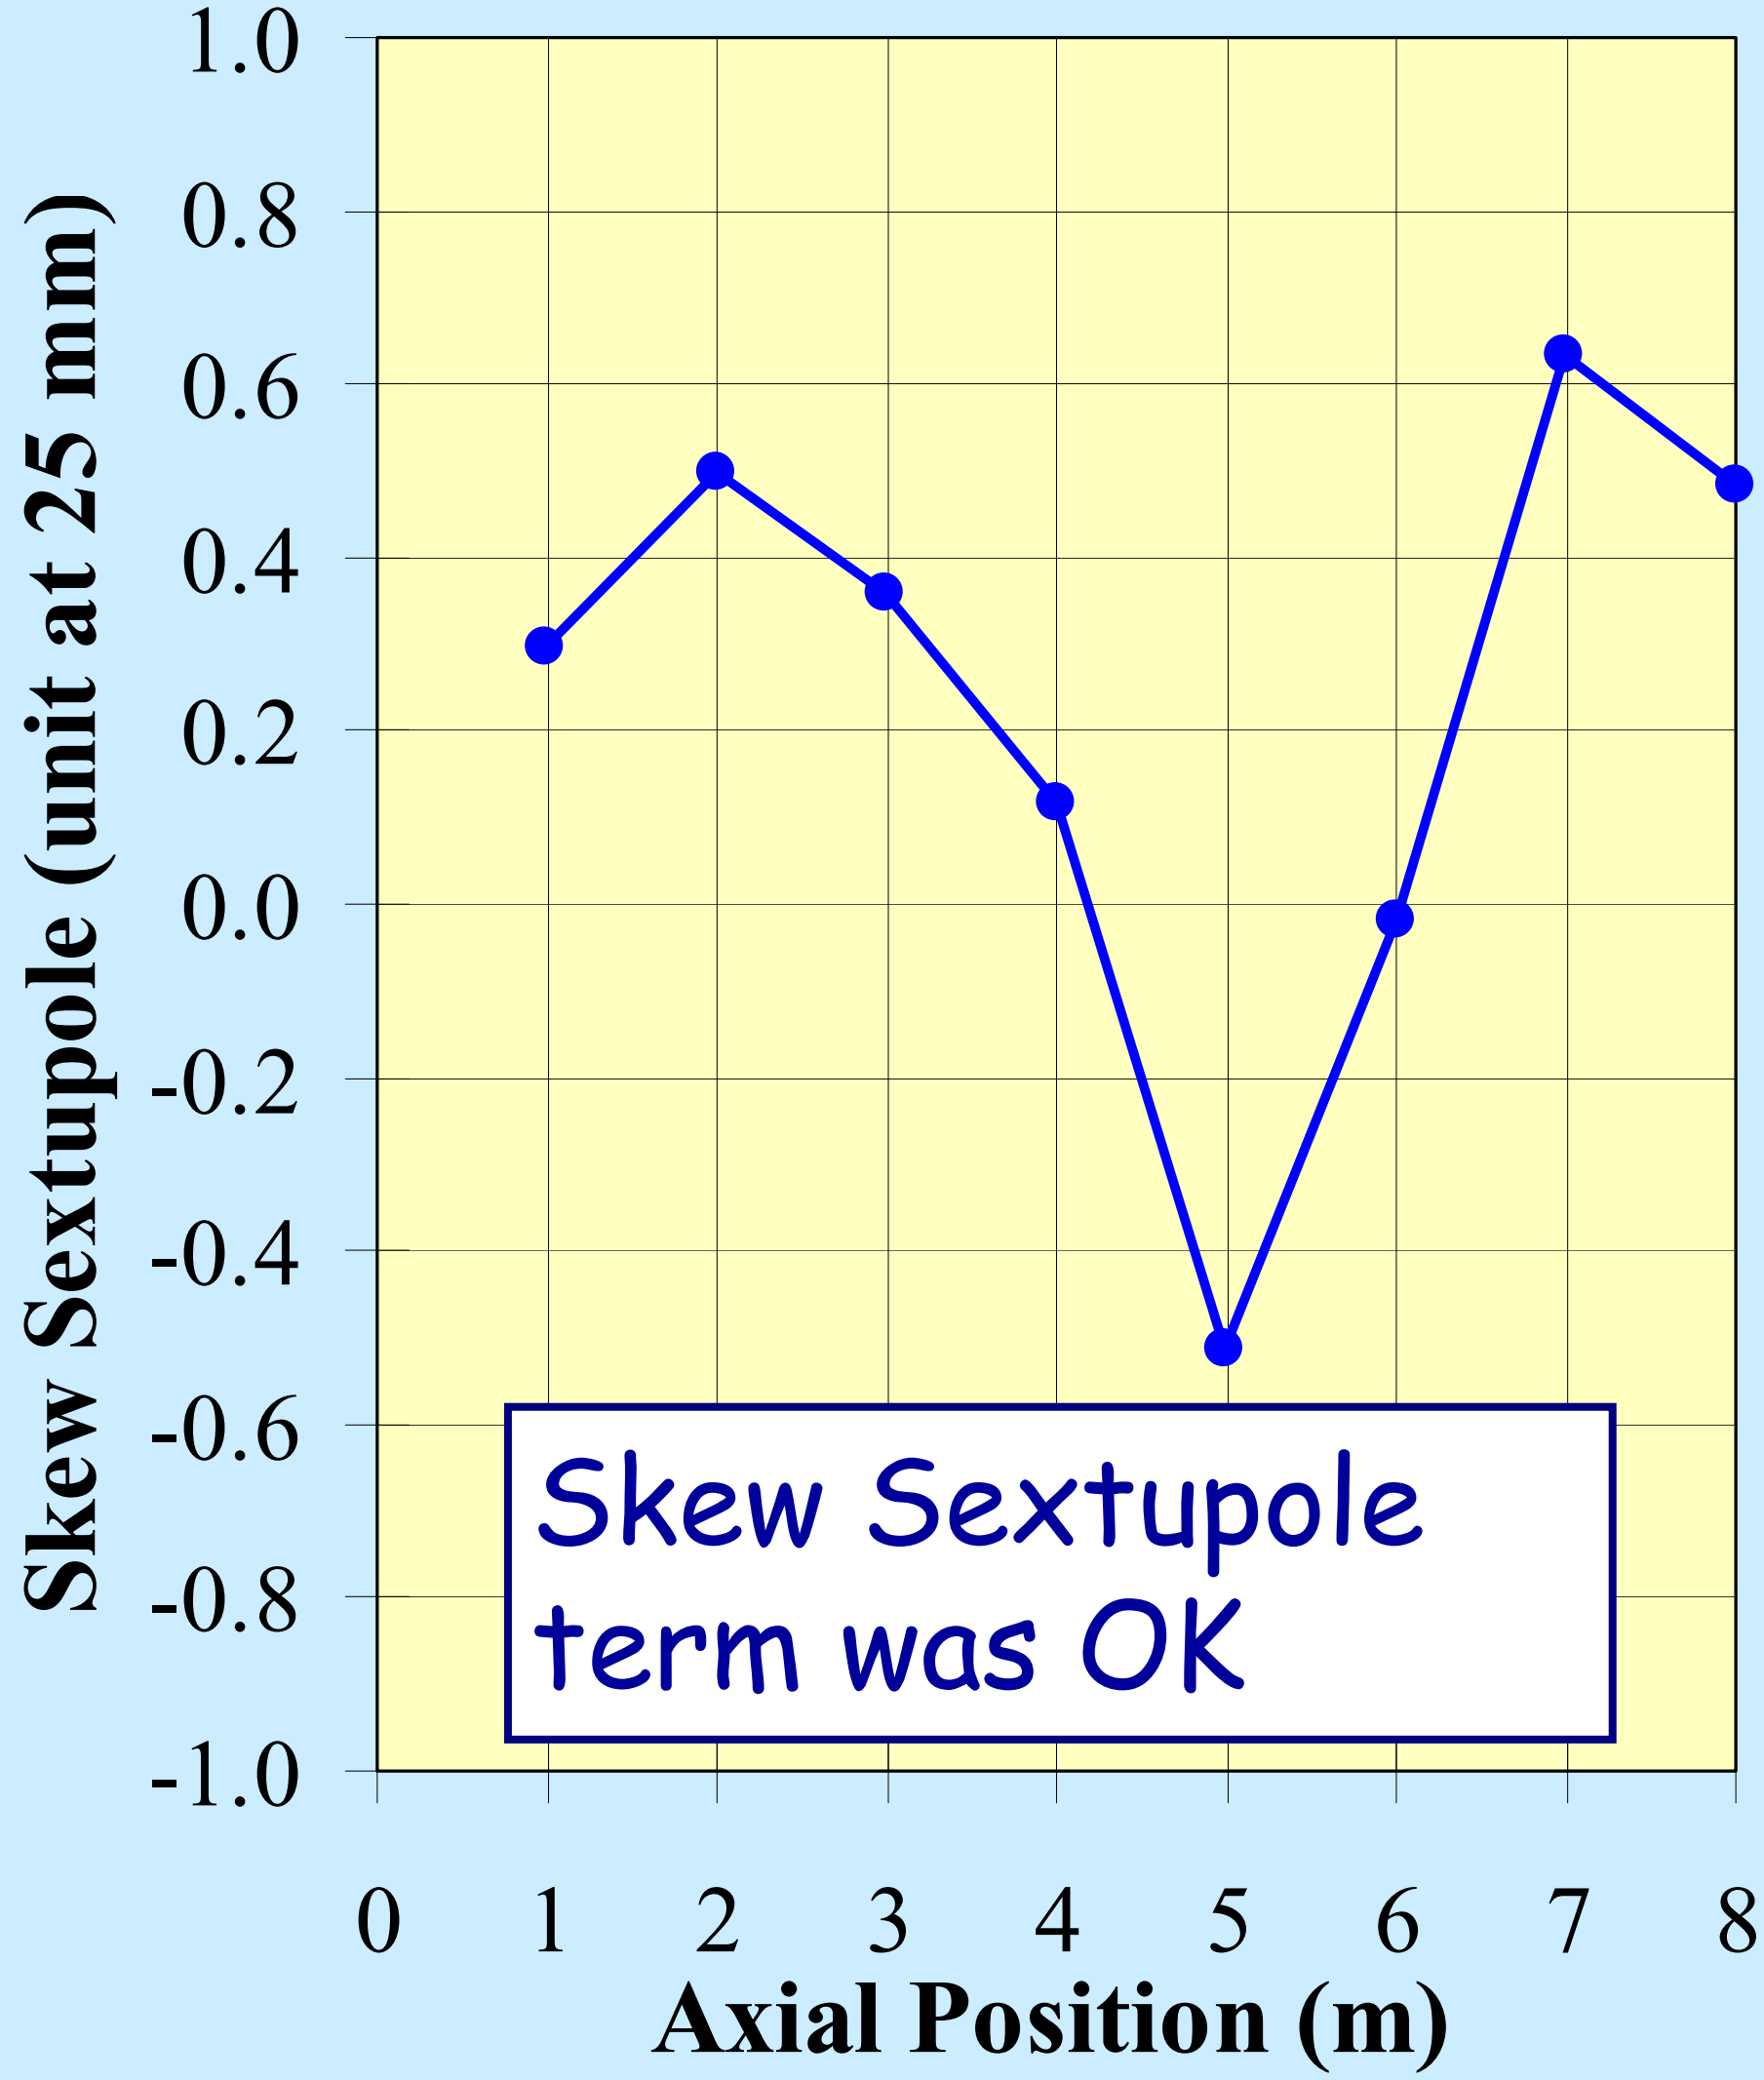
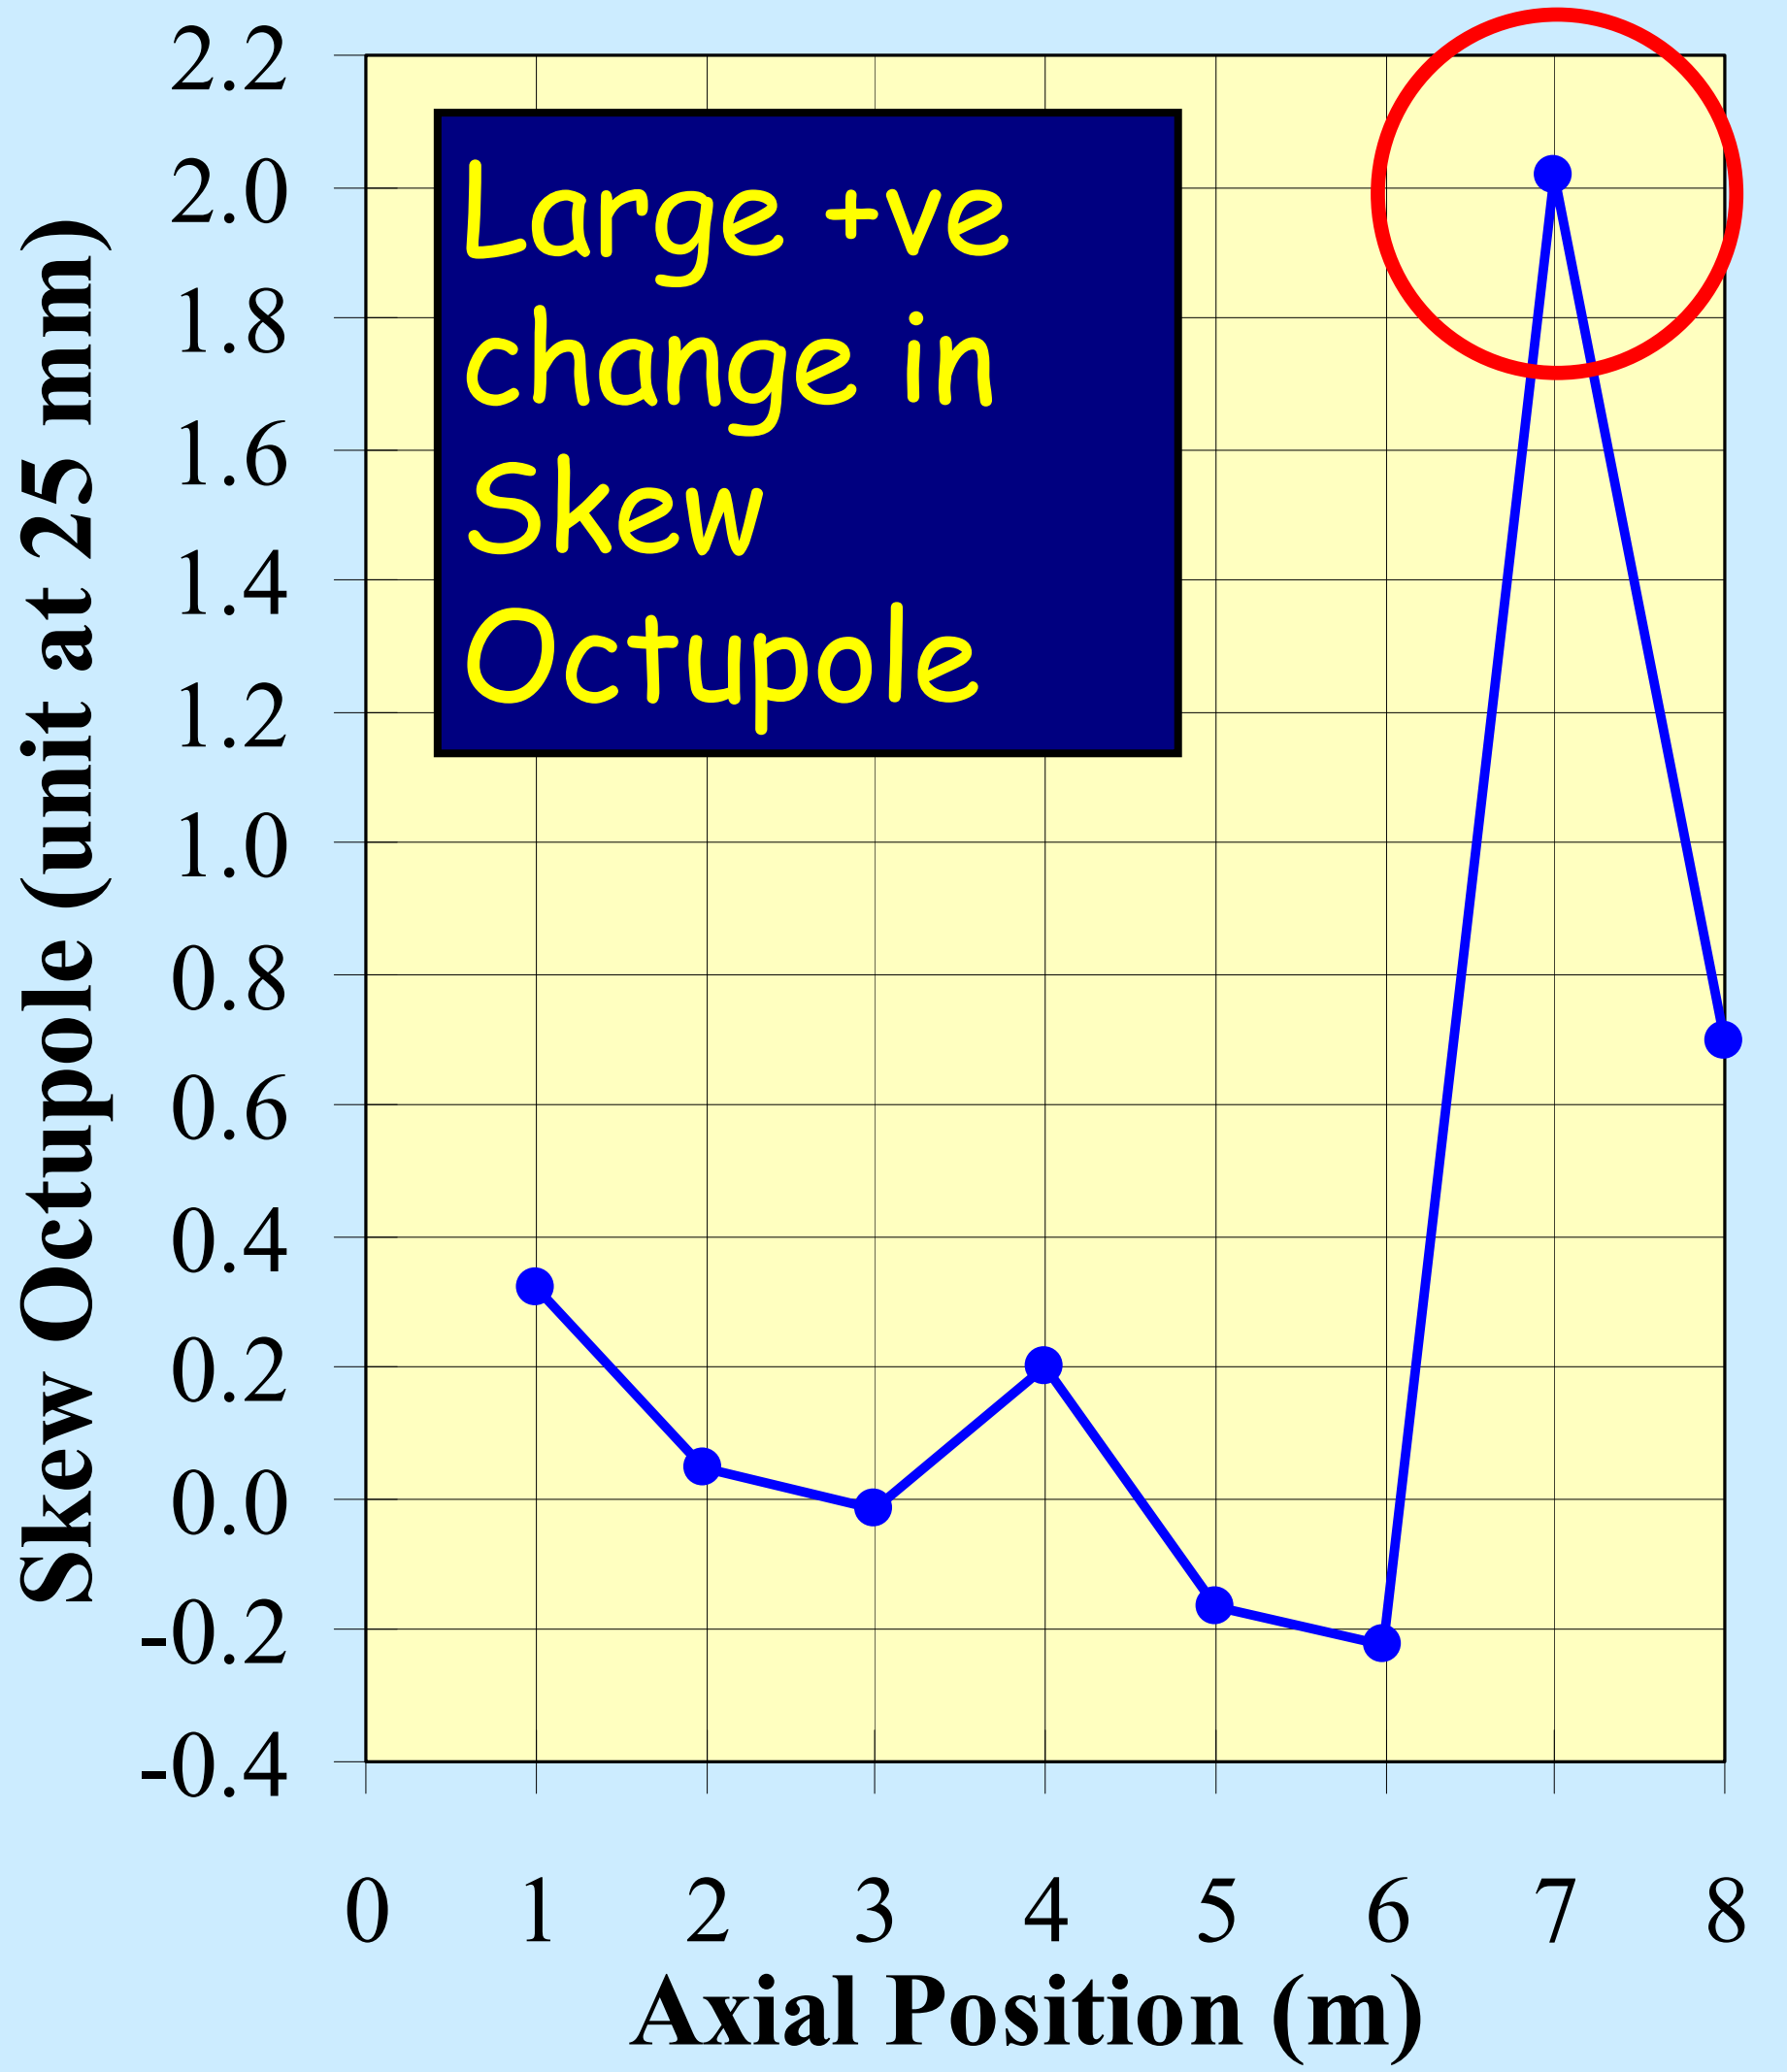
Dipole No. 149 (DRG189): Axial scan with 1 m long mole in 1 m steps

- The unusual changes in transfer function, and several harmonics, indicated a definite problem with the construction of the magnet.
- Only even skew and odd normal harmonics were affected. Even normal and odd skew terms were unaffected.
- Left-right anti-symmetry was preserved, but top-bottom symmetry was not preserved.
- Changes in the signs of harmonics indicated that the problem is closer to the pole, than midplane.
