Measurements as a Tool to Monitor Magnet Production

US Particle Accelerator School on *Superconducting Accelerator Magnets*

Dipole Example from RHIC

Shorts in a Multilayer Magnet

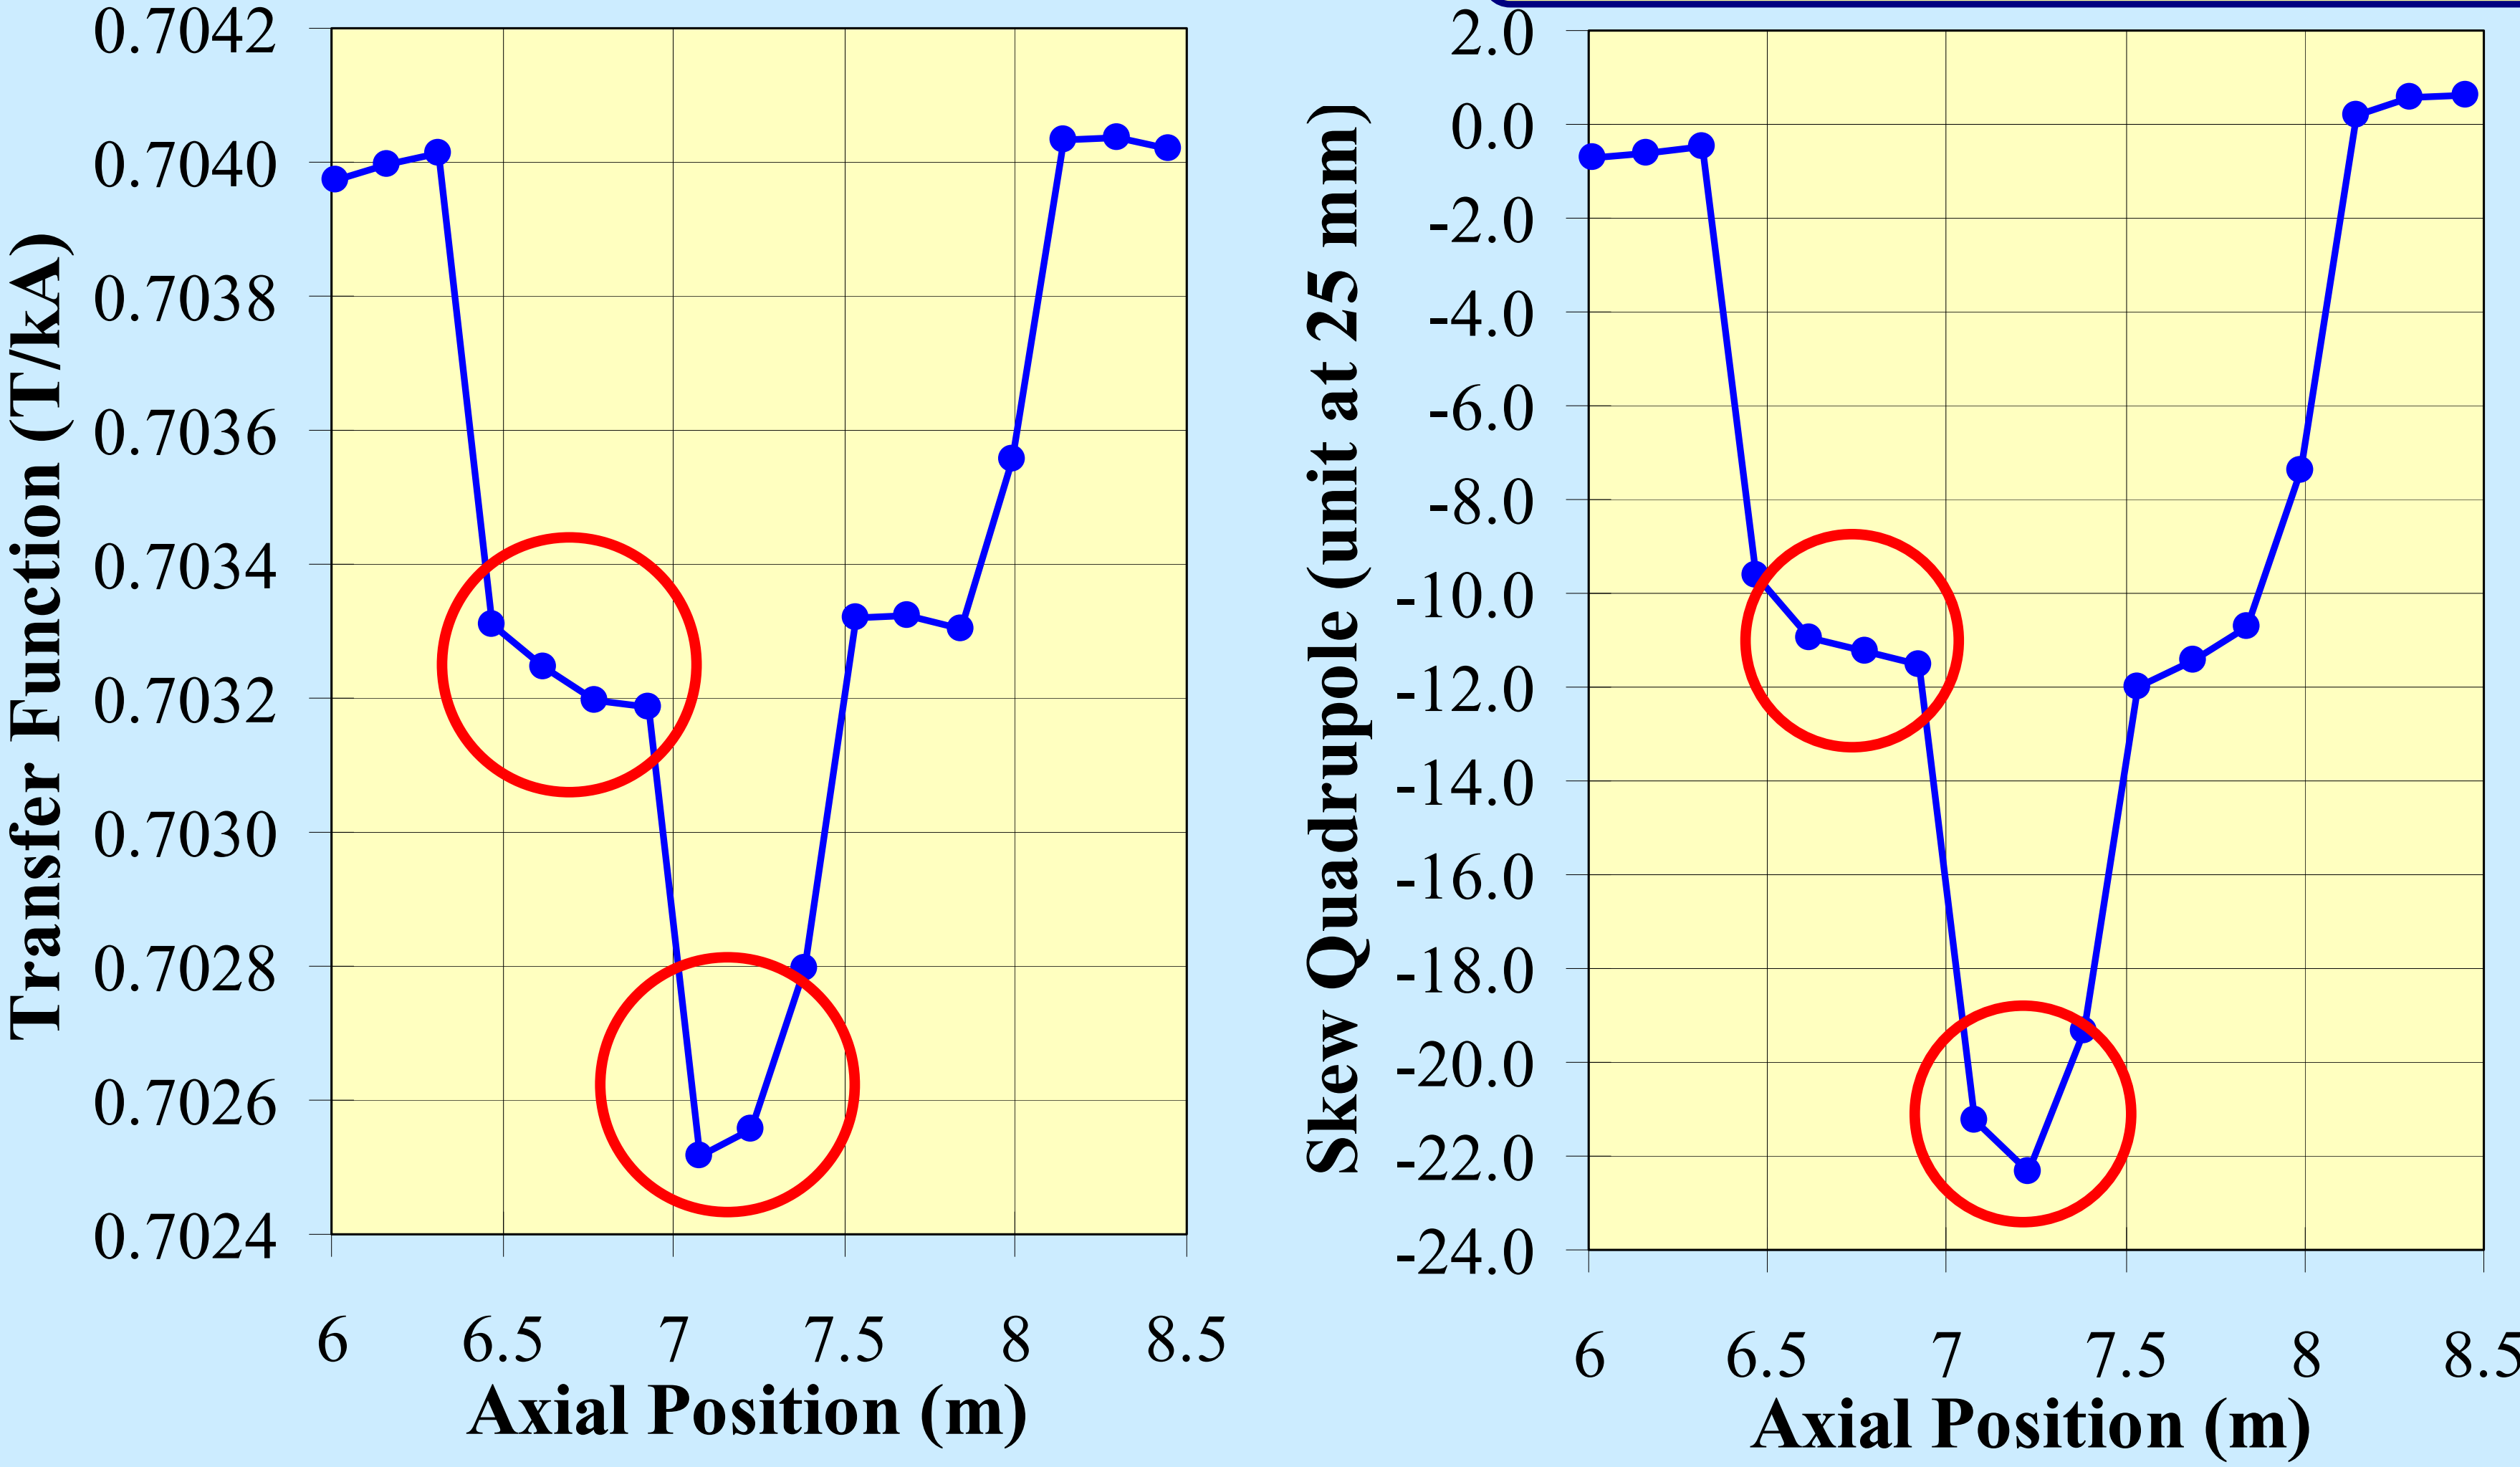
Dipole No. 149 (DRG189): Scan with 1 m long mole in 0.15 m steps

A finer scan indicated TWO similar defects !

- The nature of harmonics indicated that the coil turns near the upper pole have moved symmetrically towards the vertical axis.
- There were two defect regions, each about 0.15m long.
- RHIC dipoles use 0.15 m long RX630 pole spacers between coil and yoke. The end section spacers are different from the straight section.
- The end type of spacers were inadvertently used in the straight section. This was verified later.

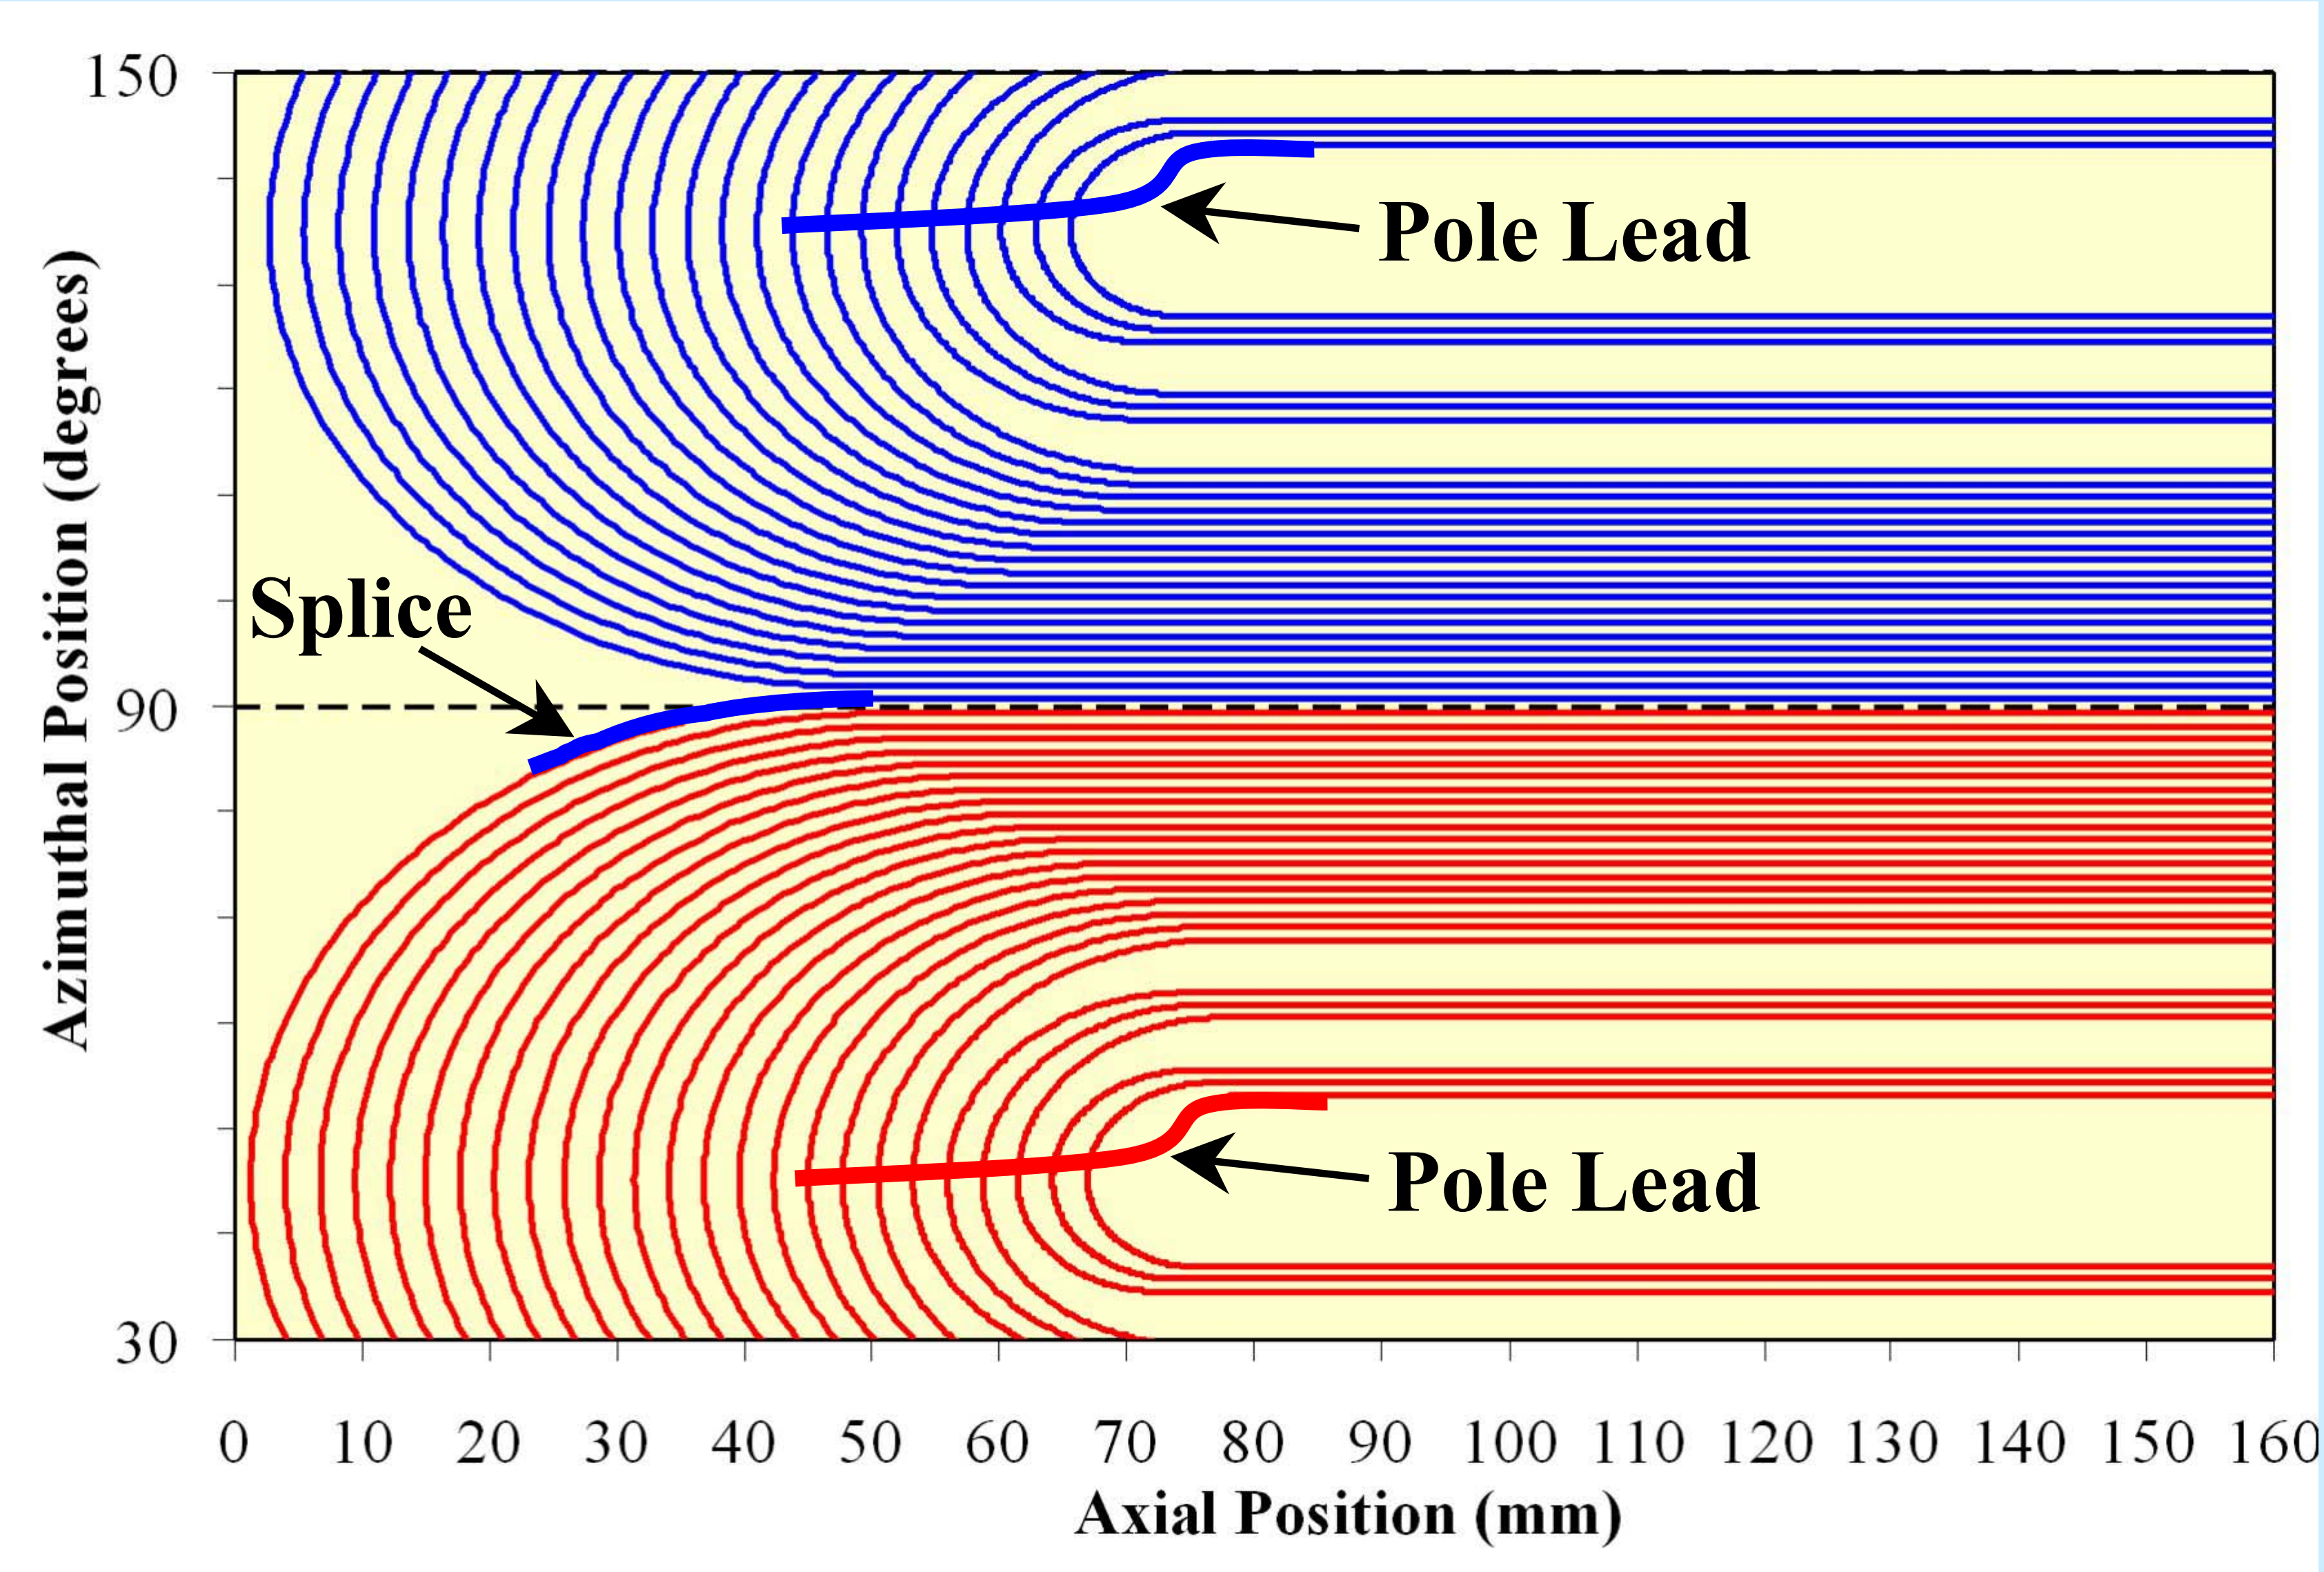
Splice Between "Sub-coils"

- BNL has recently built several multilayer magnets for the HERA upgrade program at DESY, Hamburg.
- These magnets were fabricated by winding a 1 mm diameter superconducting cable using an automatic winding machine.
- The magnets had several layers of coils with different multipolarities.
- On two occasions, the coil curing process produced electrical shorts.

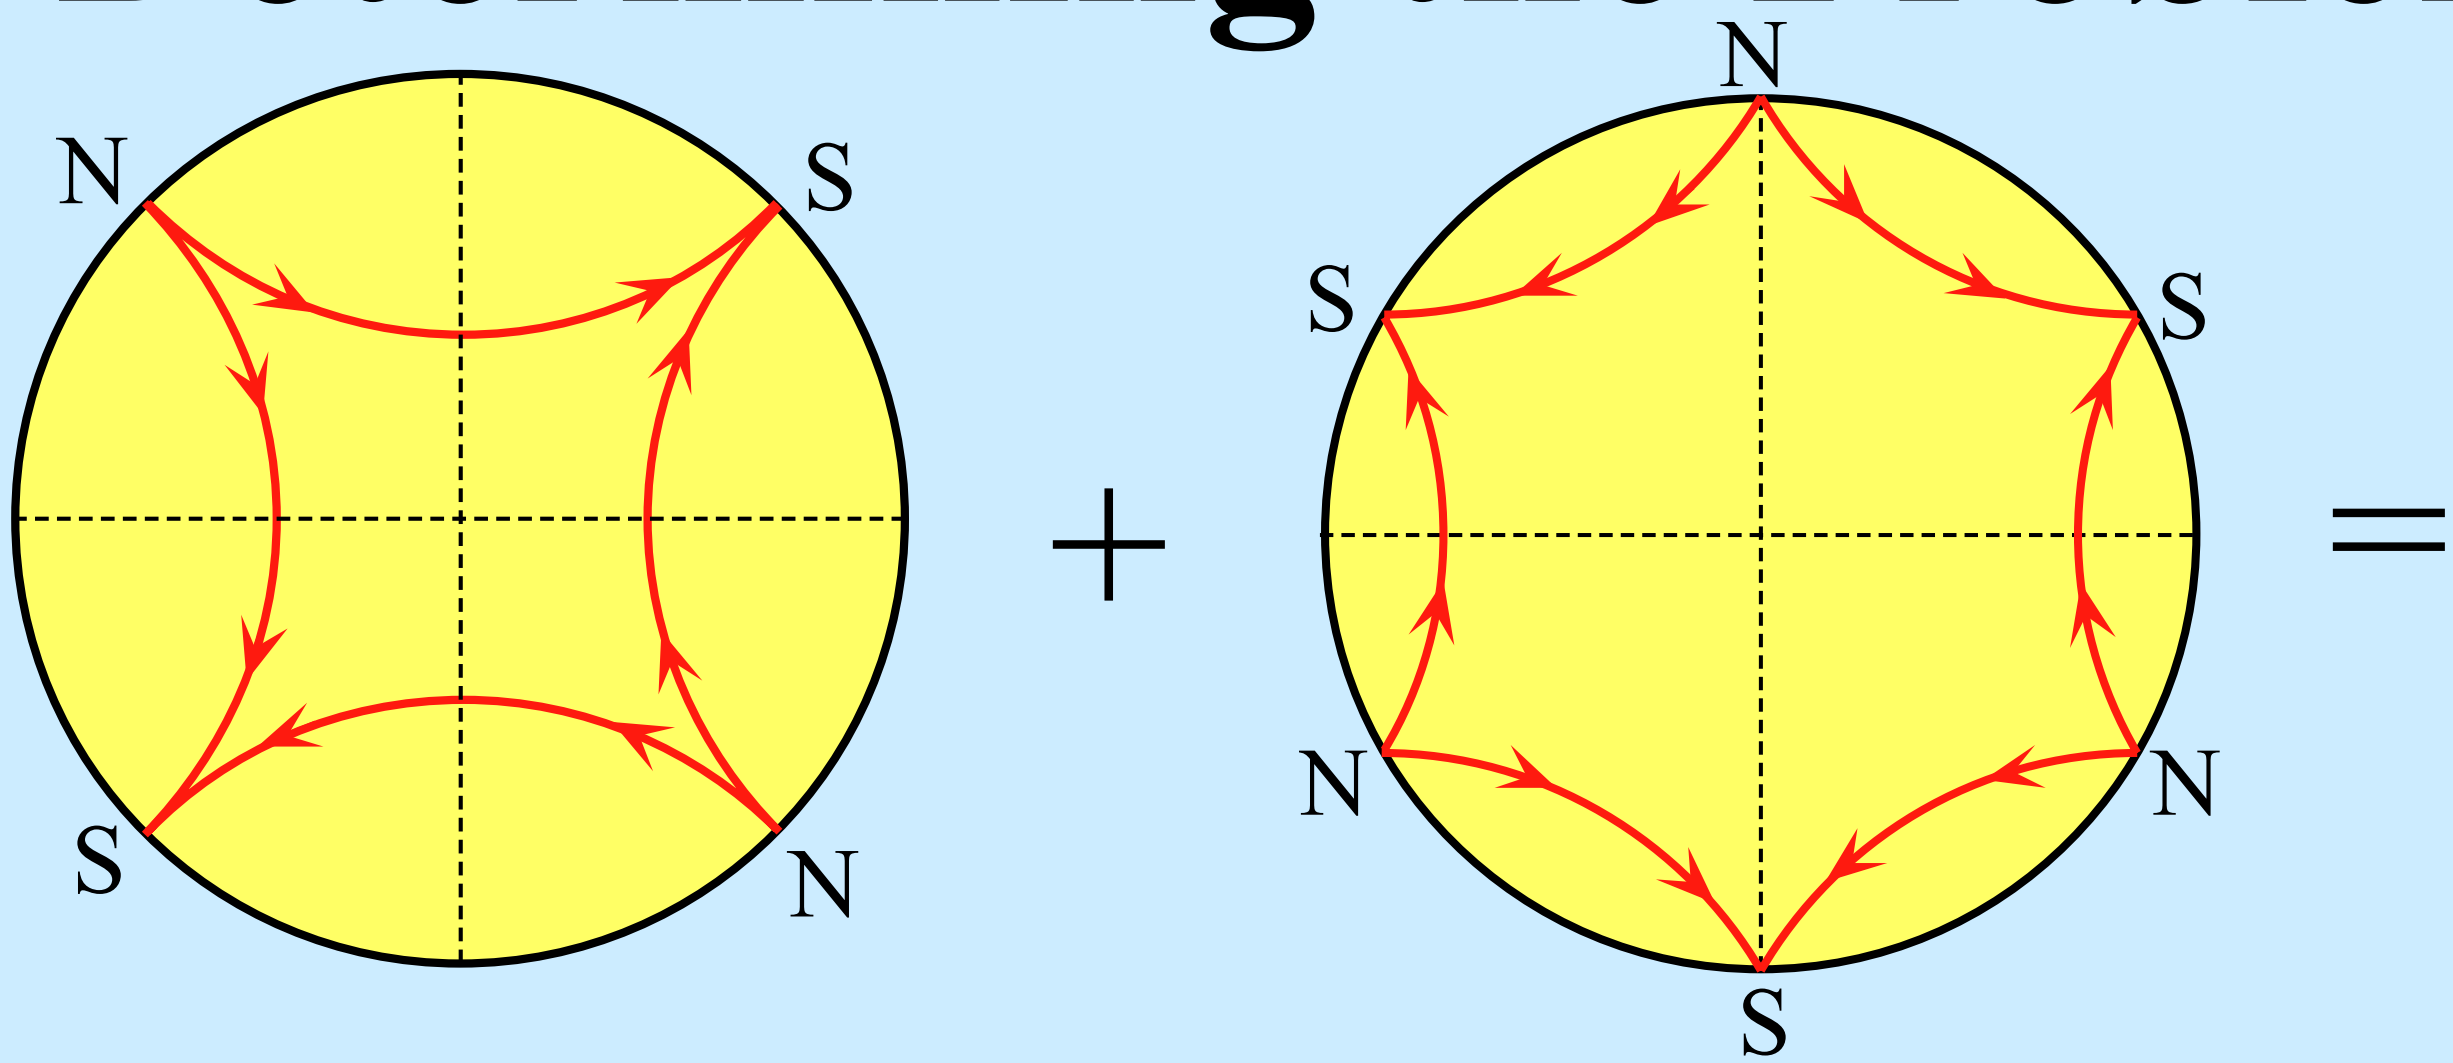
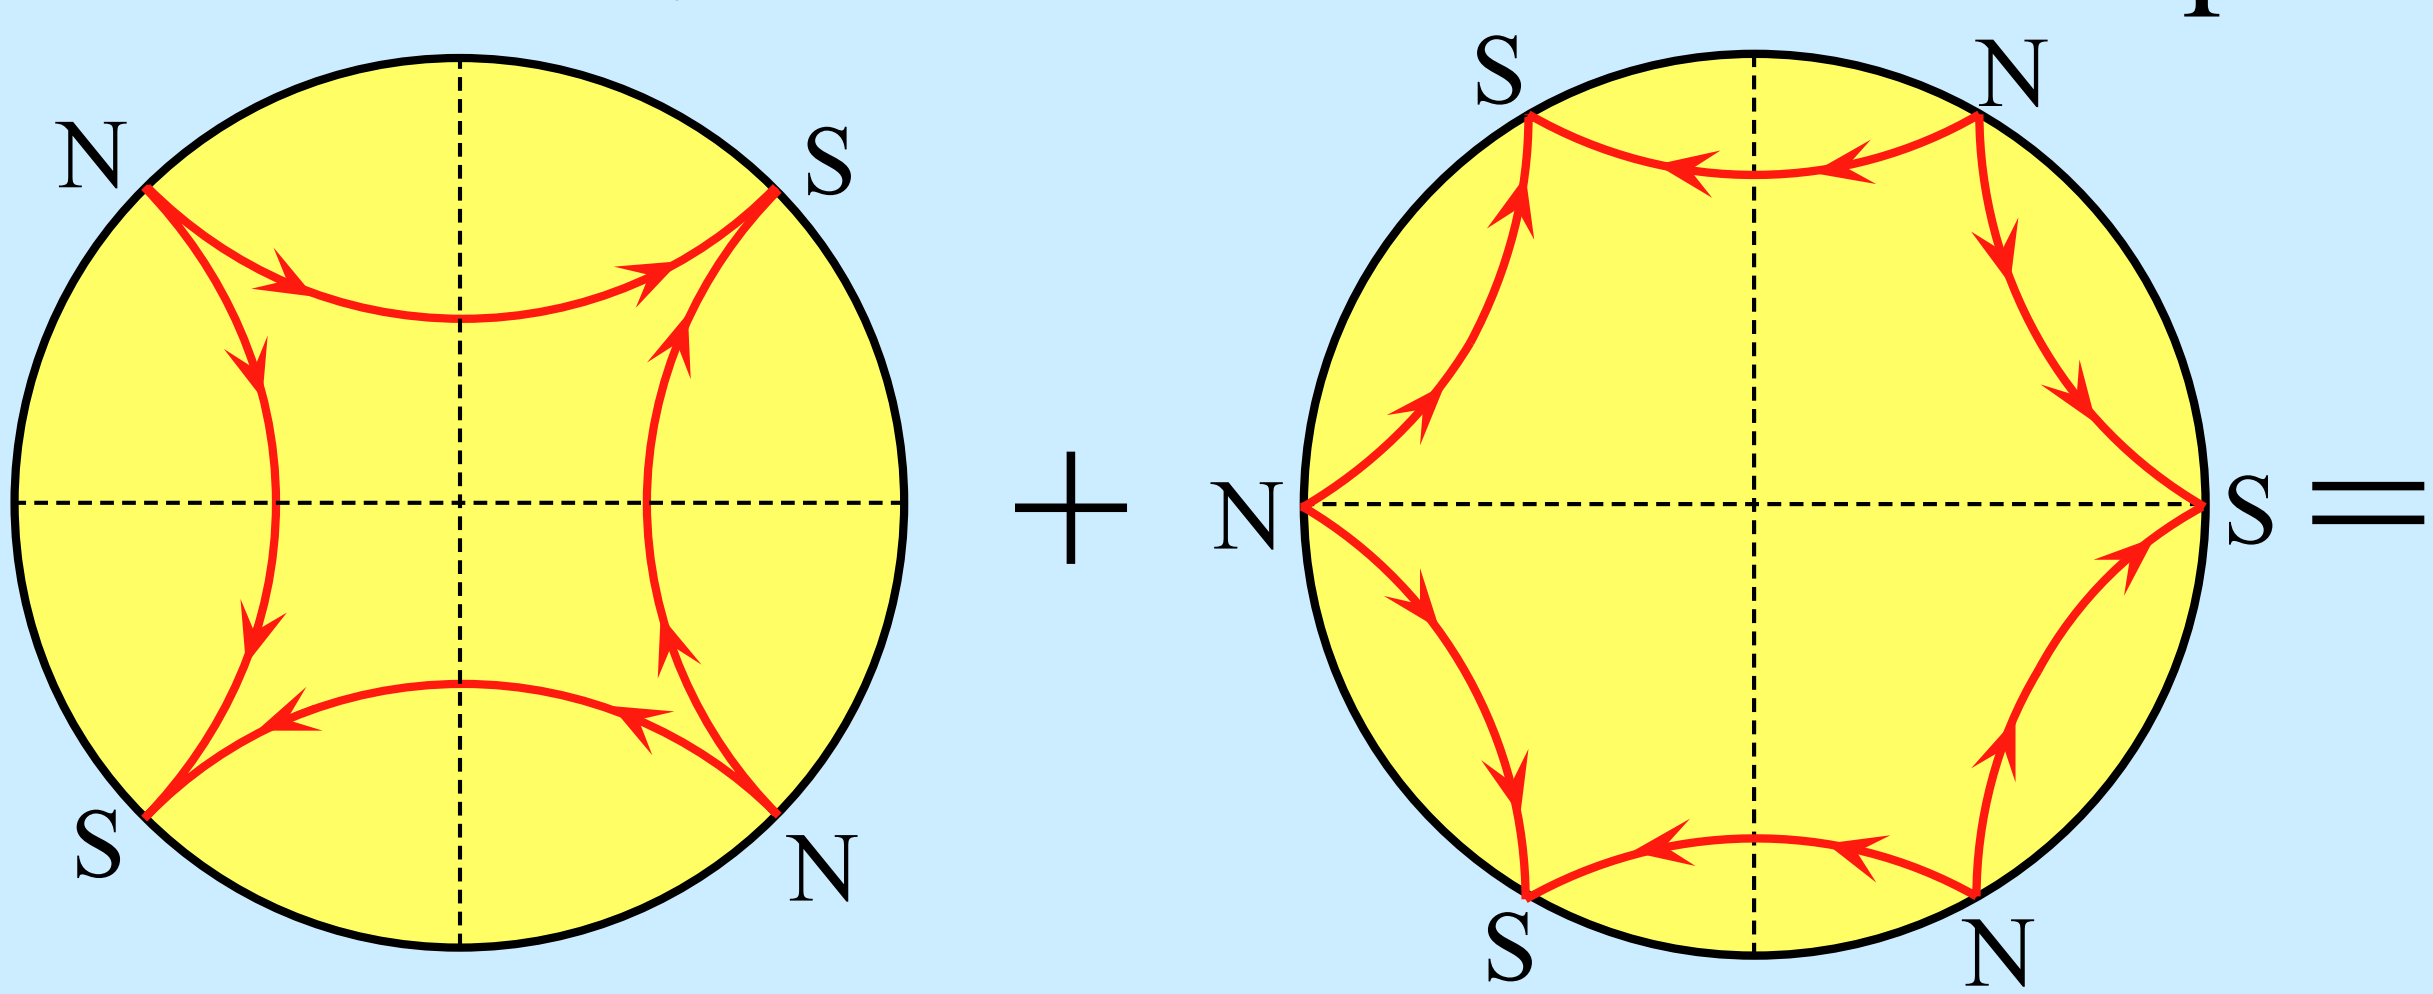
Determining the Problem Quadrant

Normal Quad   +ve Normal Sextupole

Weaker field on LEFT

Normal Quad   +ve Skew Sextupole

Weaker field on TOP

Missing Current in the 2nd Quadrant

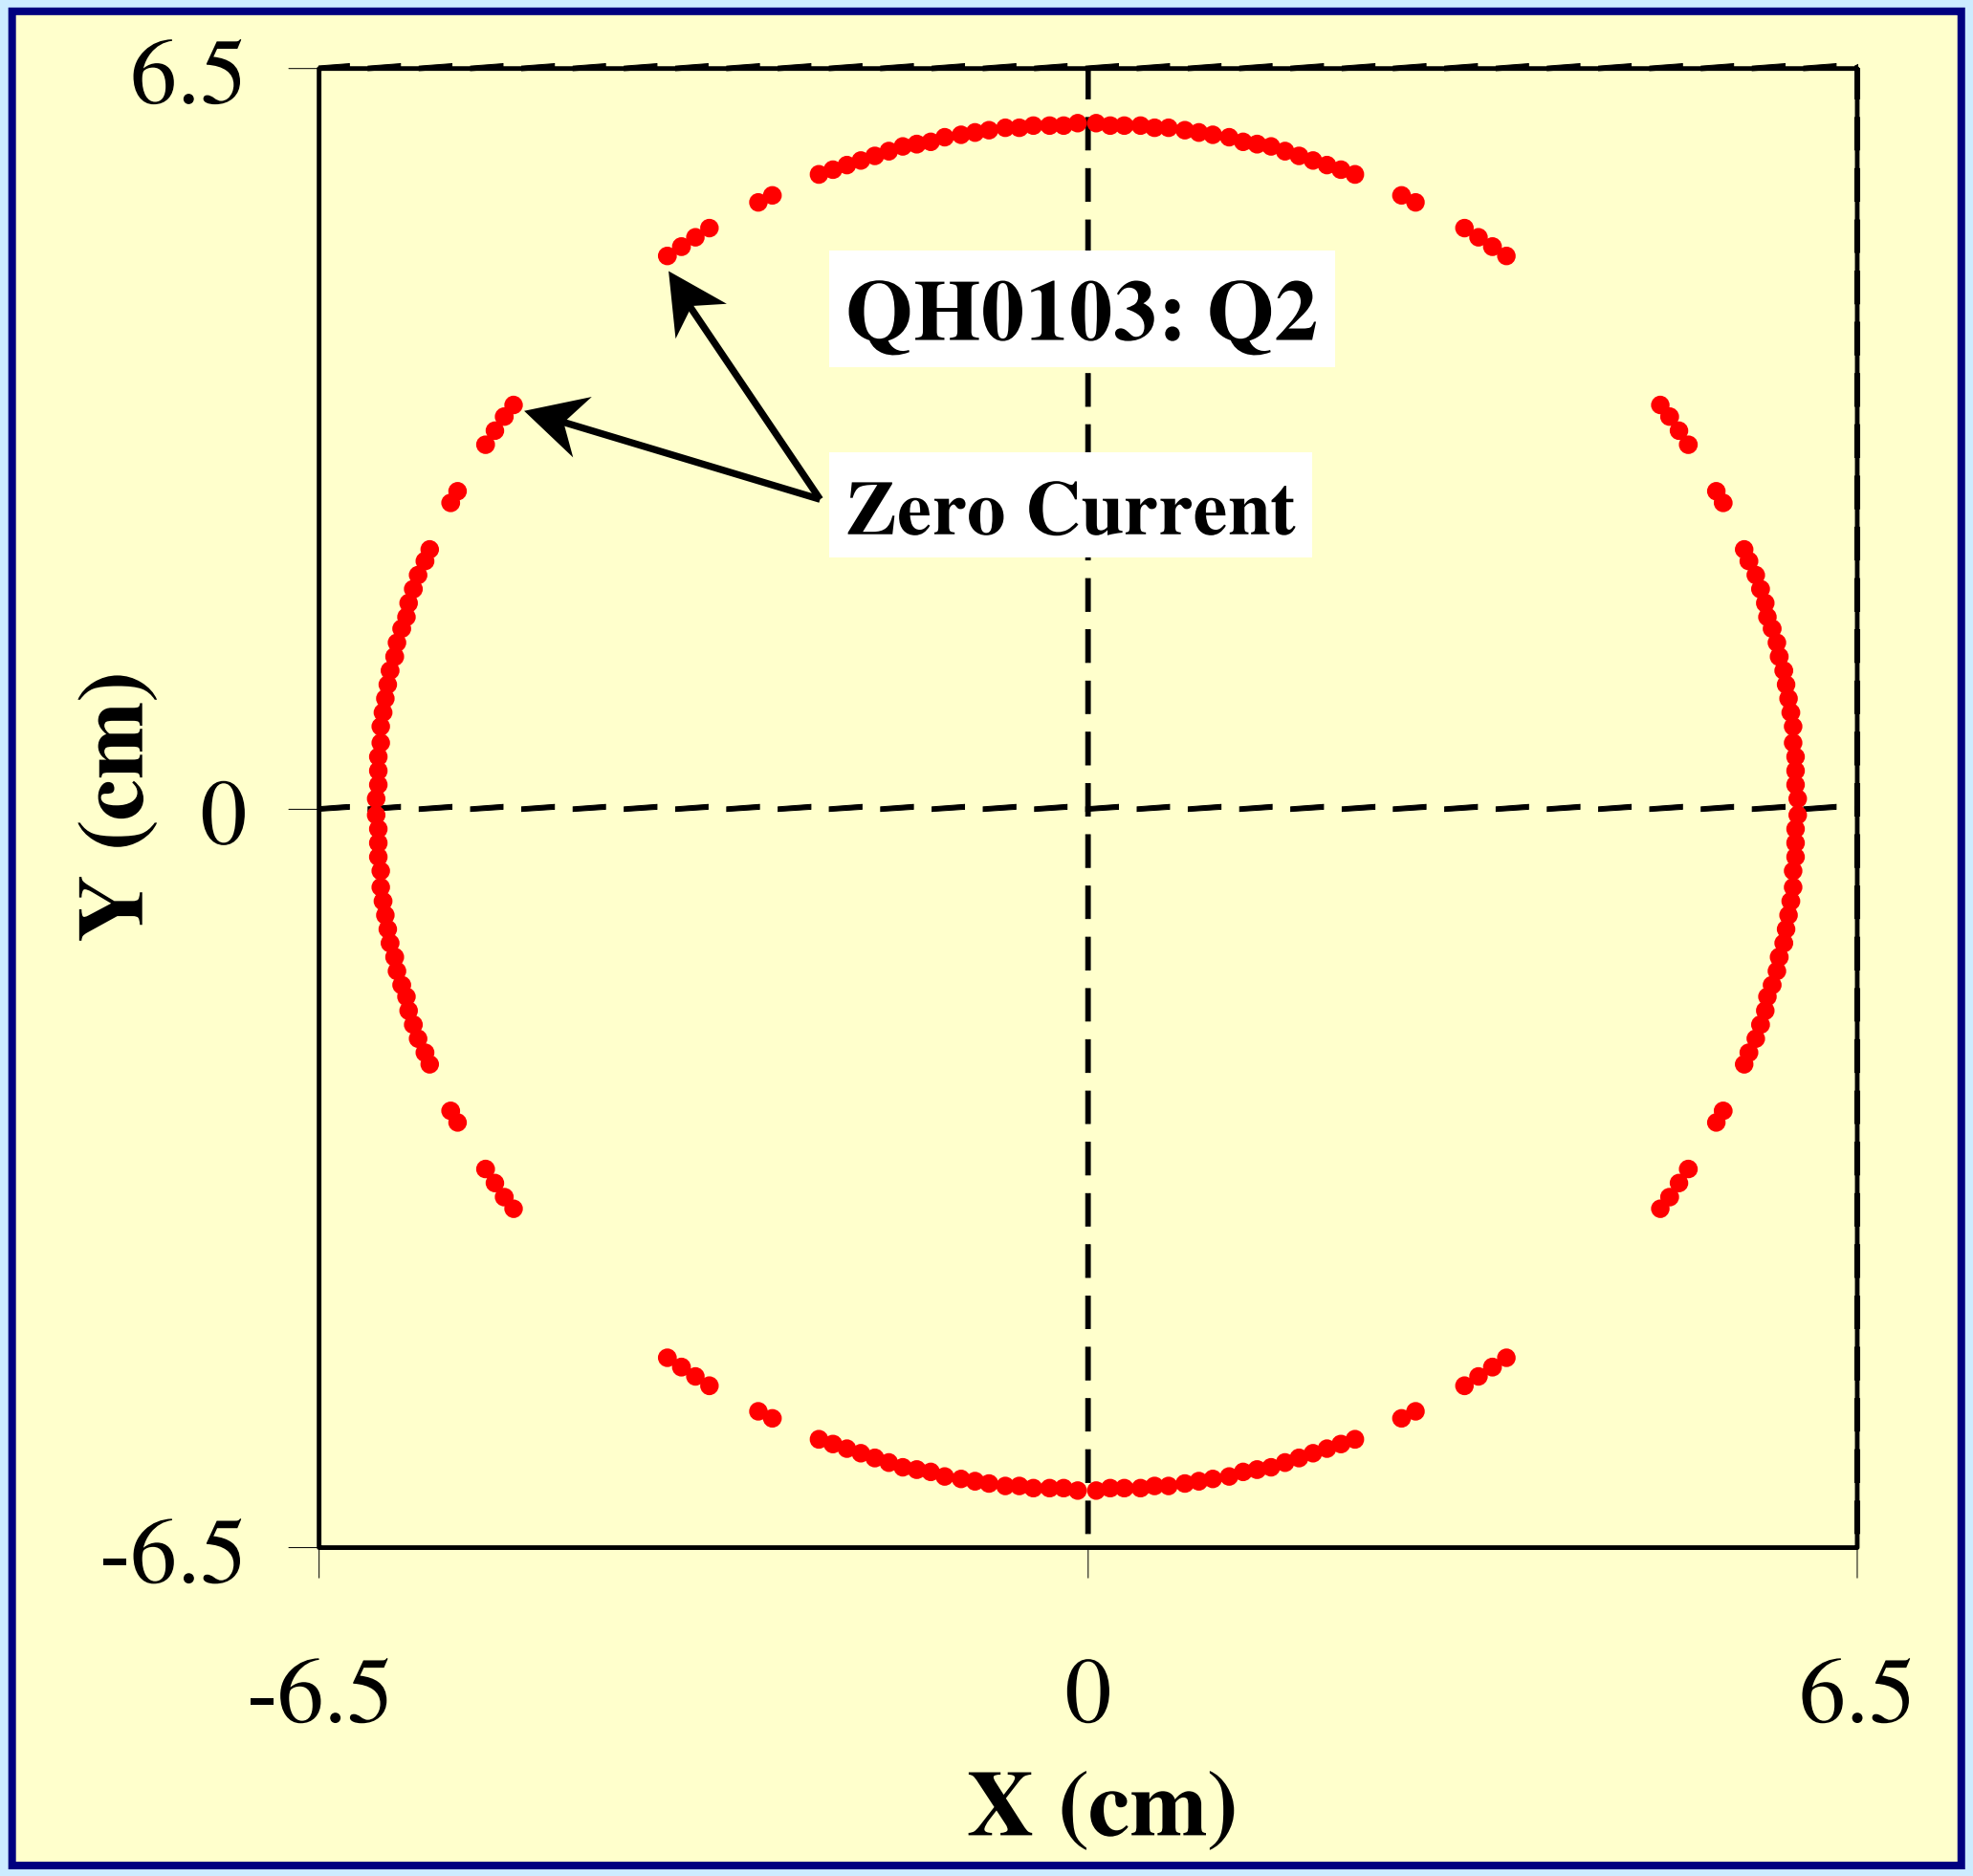
Modeling Field Errors in QH0103

- Most likely area: pole lead in the 2nd quadrant.
- Would bypass current from the pole-most turn.

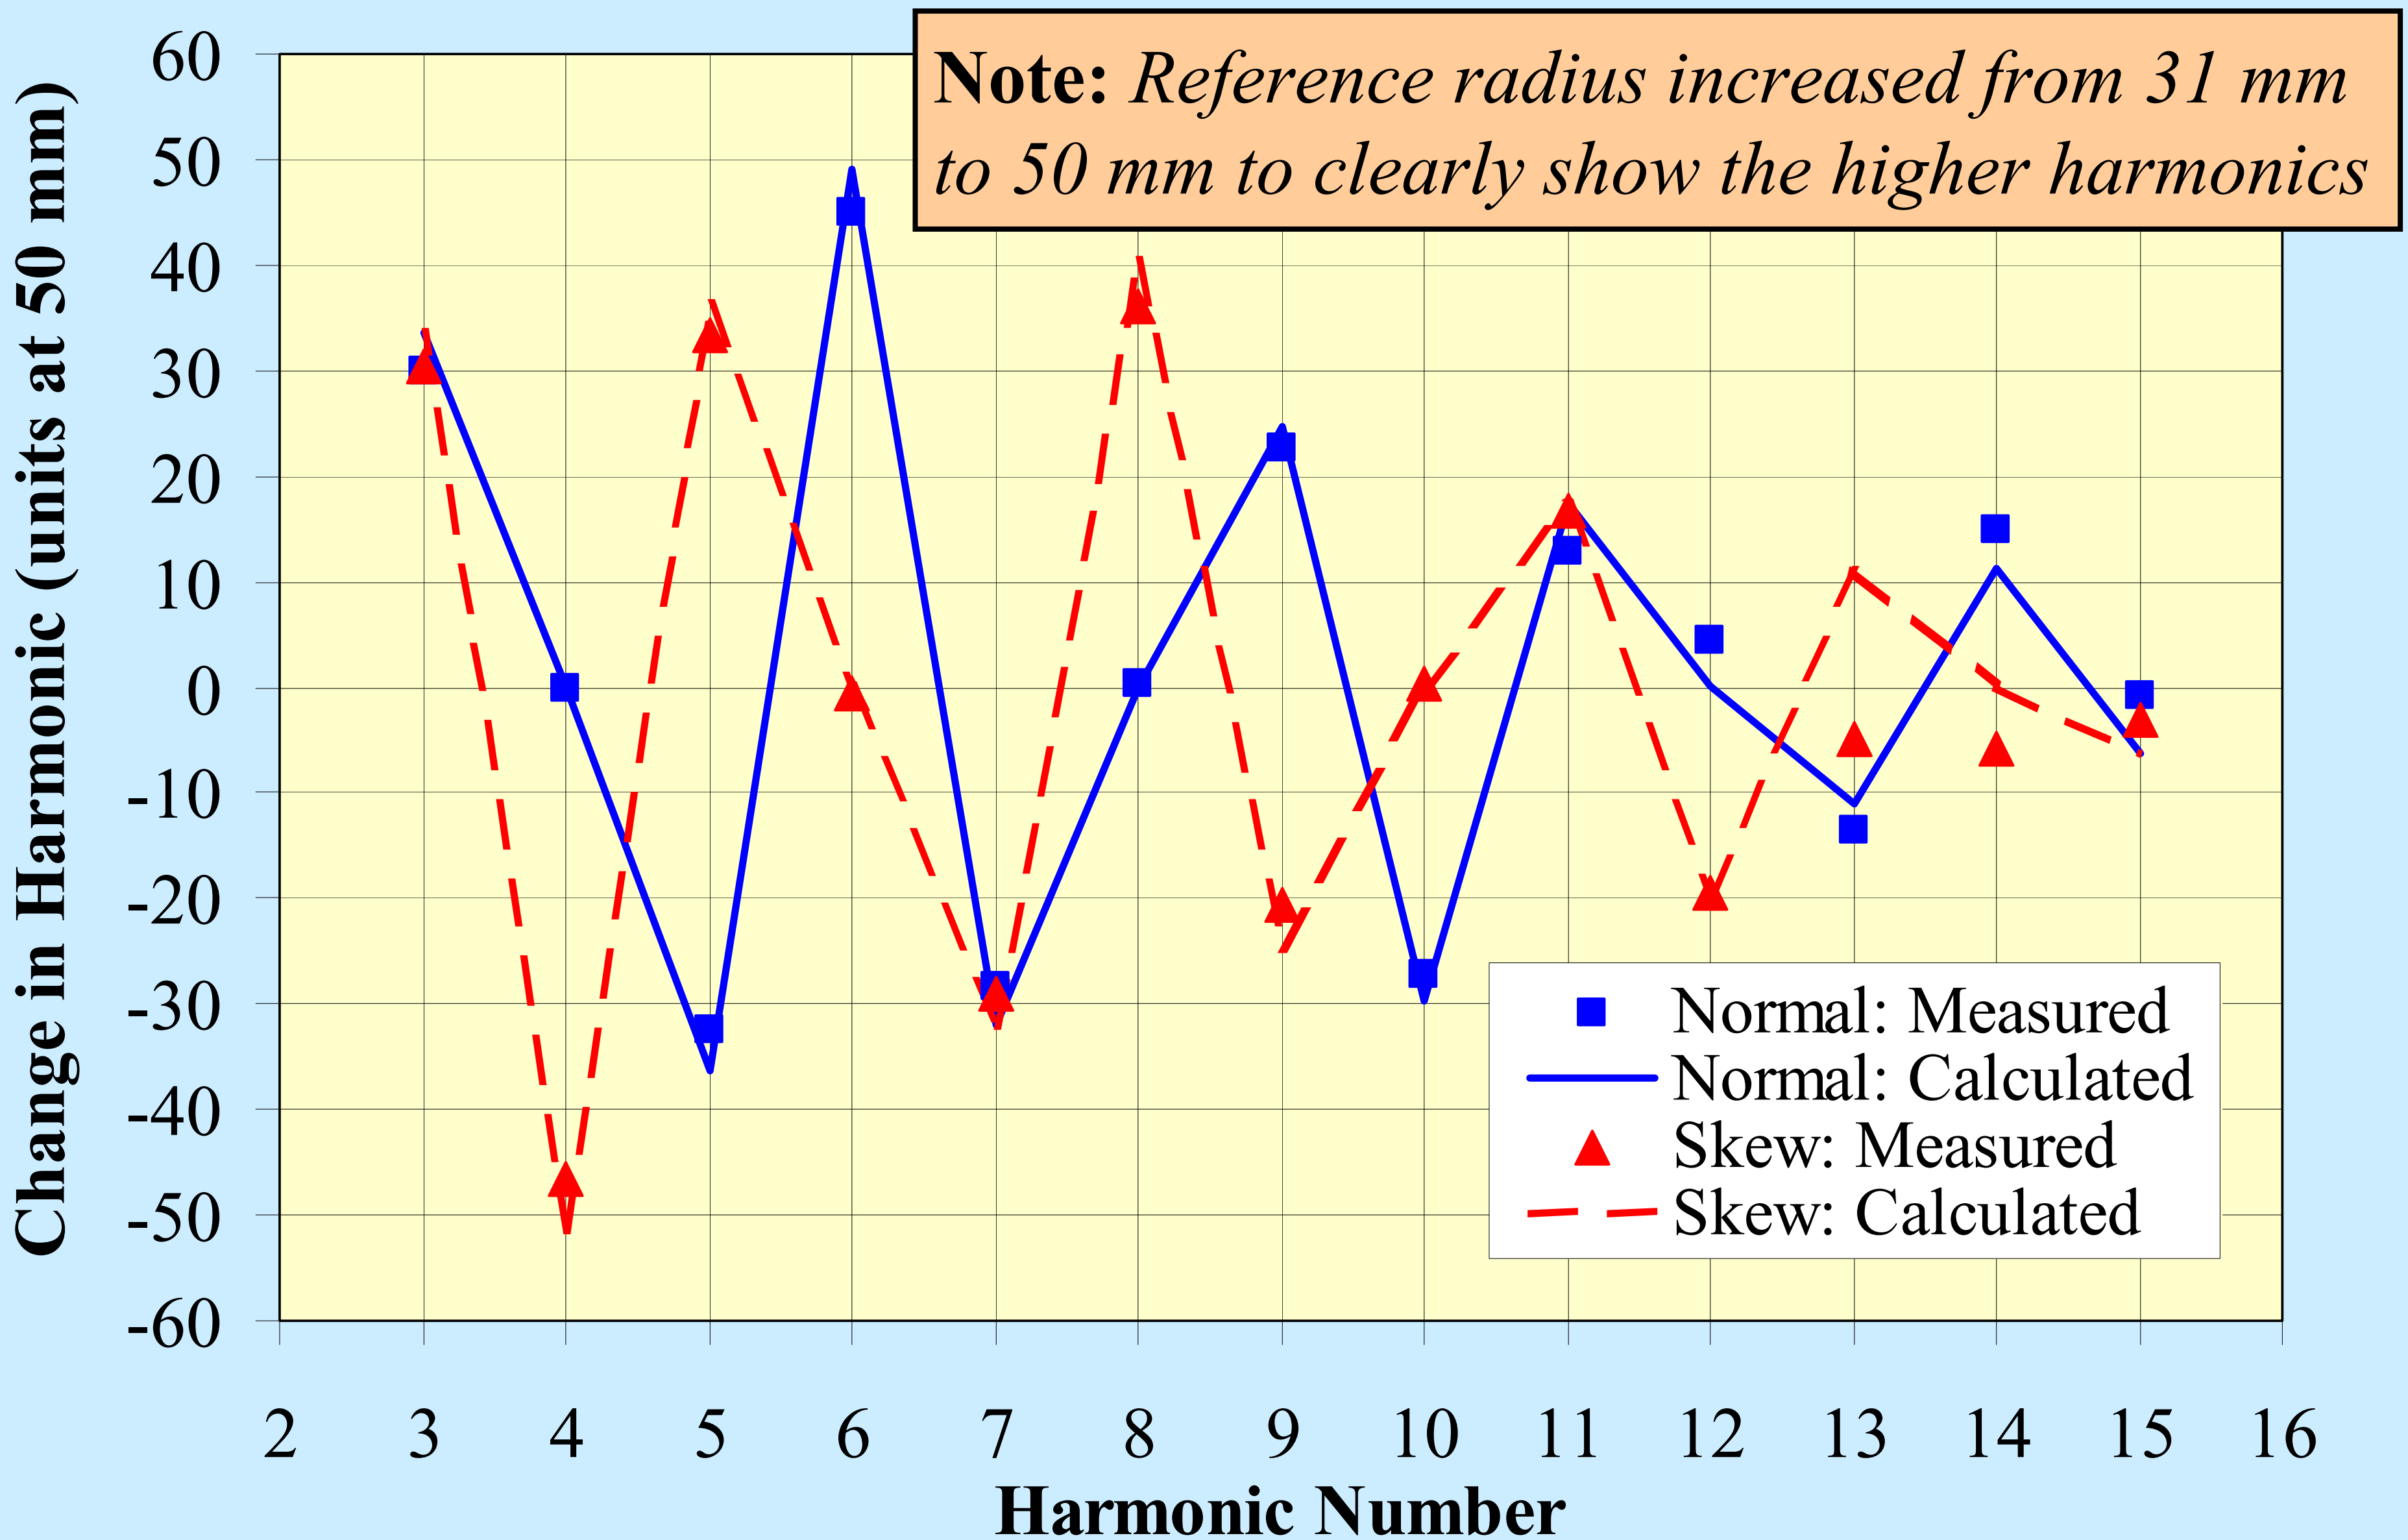
Computed Vs Measured Changes

- Large changes in the harmonics were observed in the main quadrupole of the magnet QH0103 after all the layers were completed.
- Magnetic measurements were NOT carried out after each step. So, it was difficult to judge at what step the problem could have occurred.
- Warm measurements were carried out at 0.25A on individual layers using the voltage taps as current leads.
- The measurements indicated a problem with the 2nd quad layer, which was burried under 3 more layers.
